# Report of Property Inspection

Engineer's Inspection Report for [REDACTED]  
[REDACTED]

Prepared on Instruction from [REDACTED].

[REDACTED] Rev 1.0

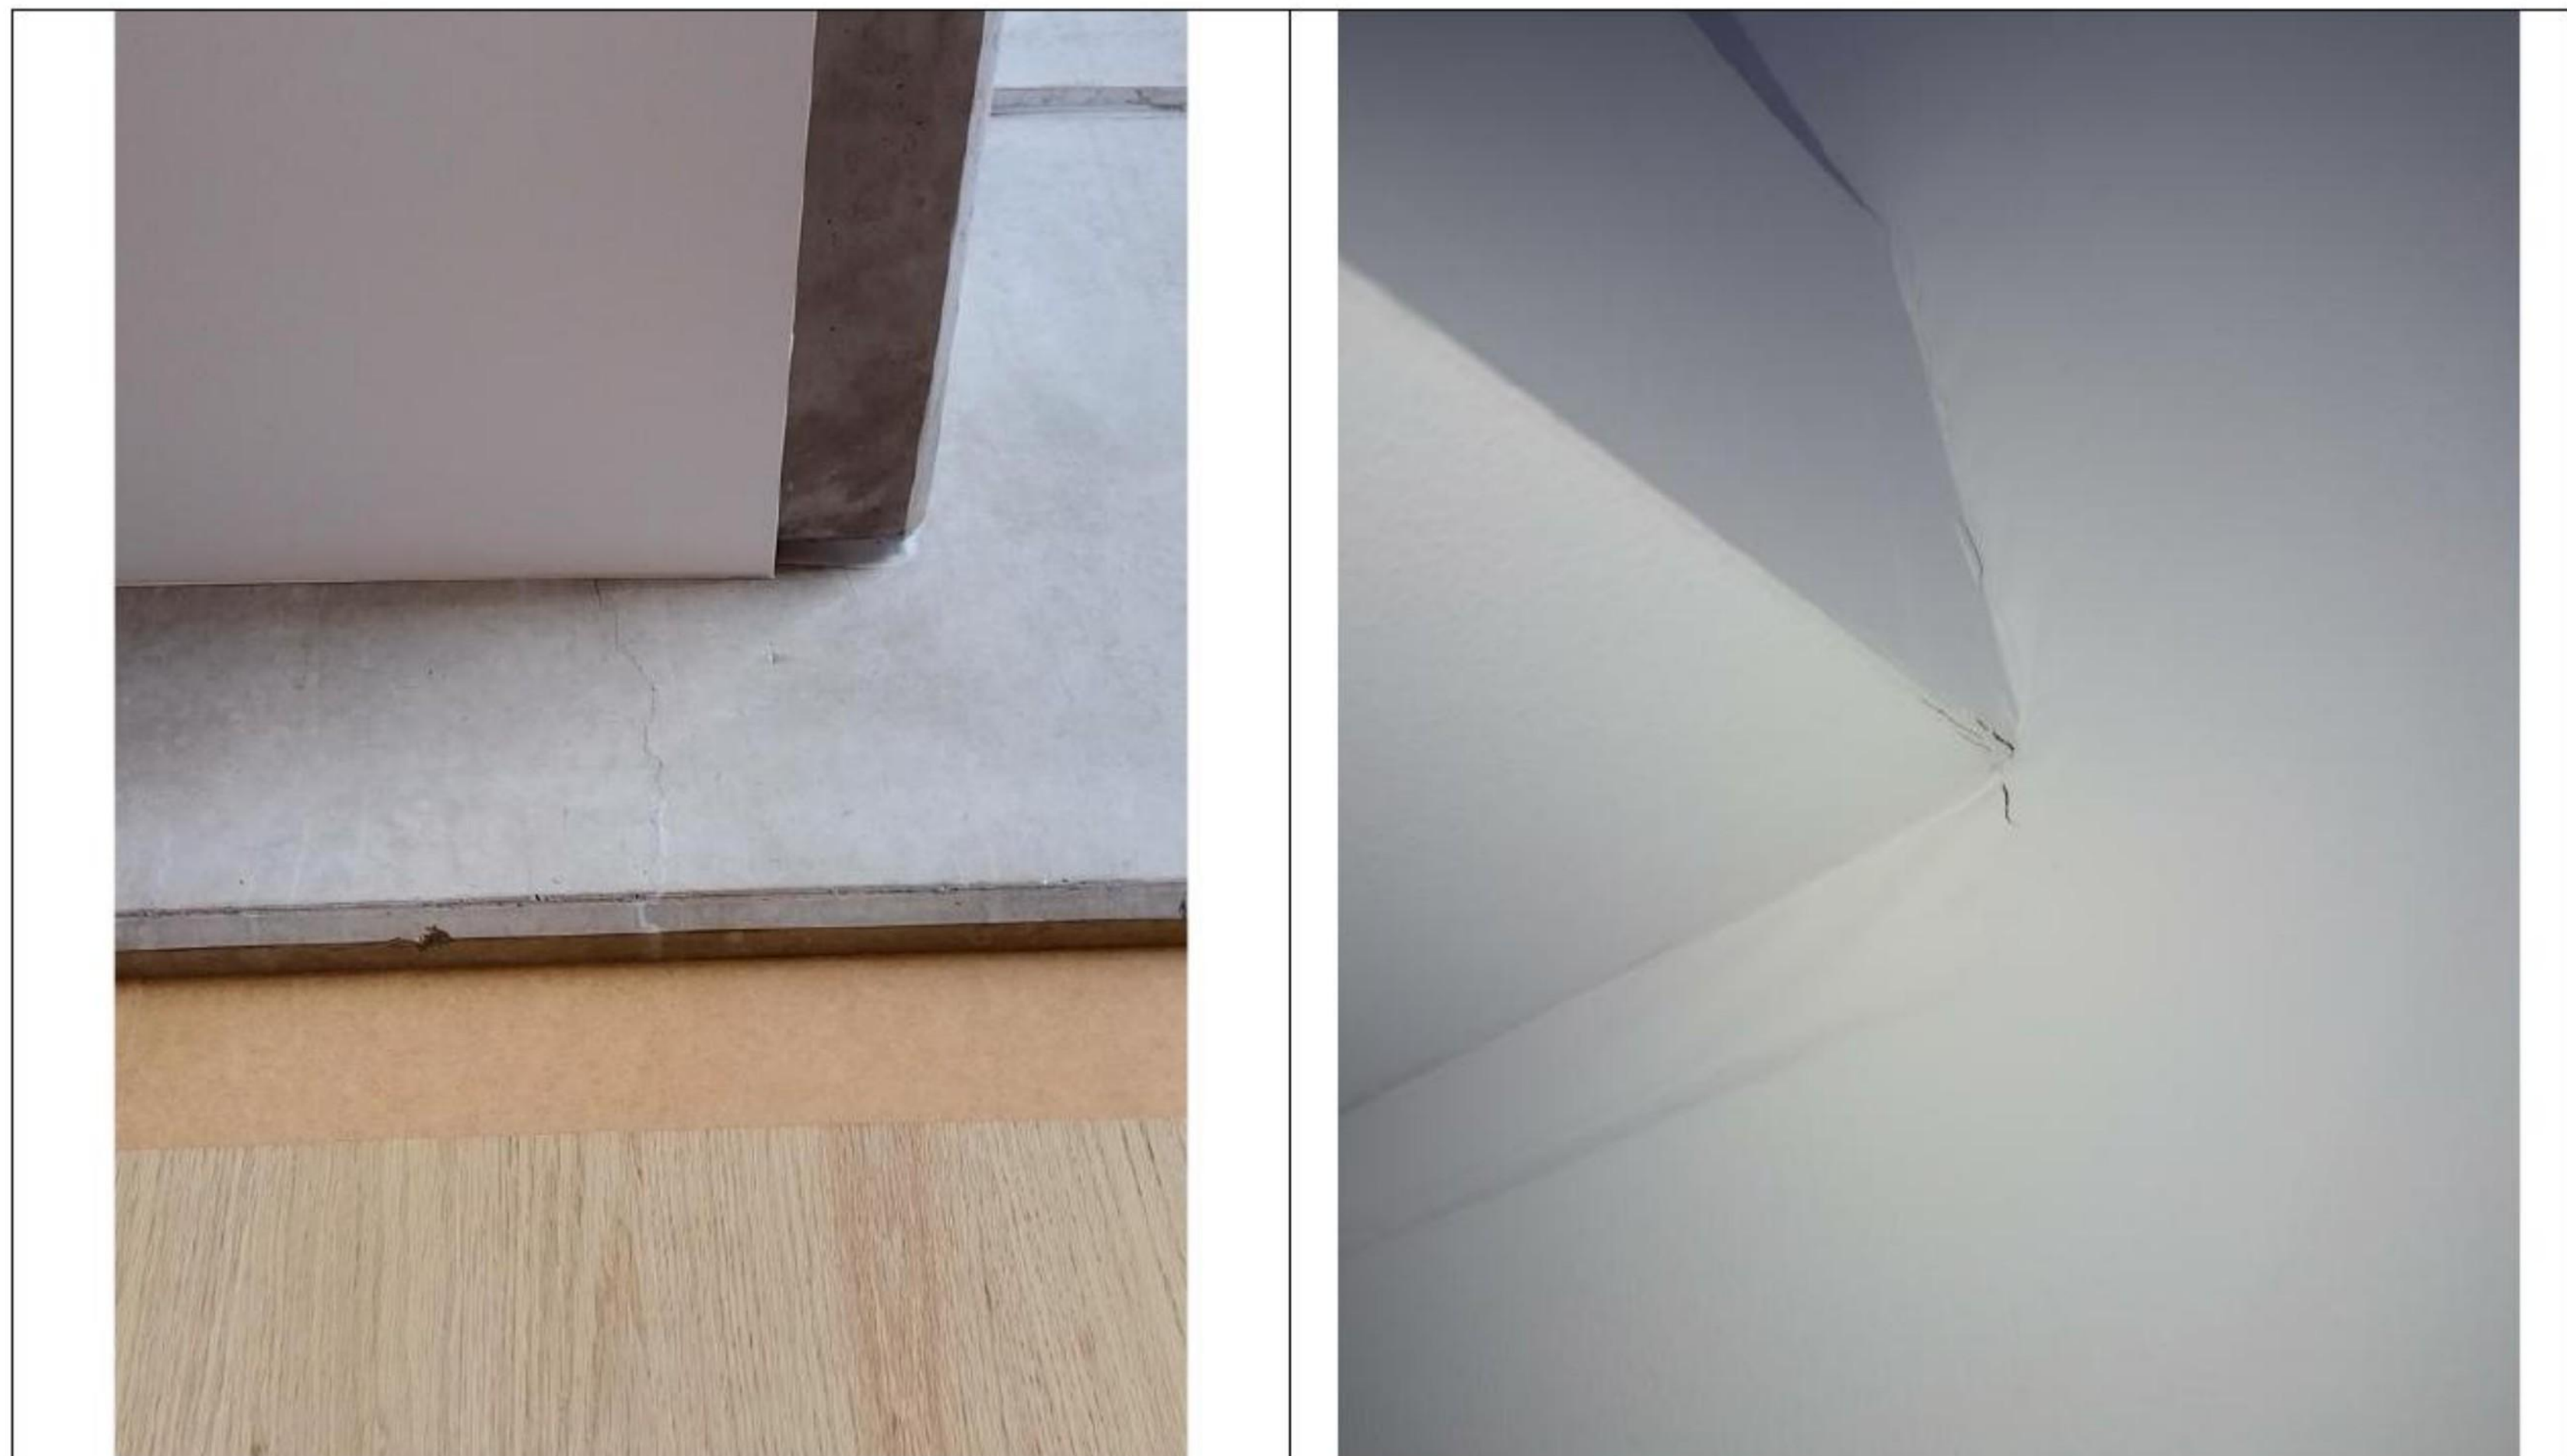
##### 5.2.1. Internal Wall Structure

A few cracks approximately 1-2 mm were observed on the wall surface at the office areas and the kitchen areas.

Hairline cracks (1–2 mm wide) were observed on the internal wall surface at a few different locations mentioned above.

In accordance with AS 2870:2011, the observed wall damage is classified as **Slight (Category 2)** for the external elements.

Routine monitoring and cosmetic repairs are sufficient unless the existing cracks widen or new cracks develop. Cosmetic repairs should be undertaken only after the leakage has been rectified to minimise the likelihood of the defects reappearing.

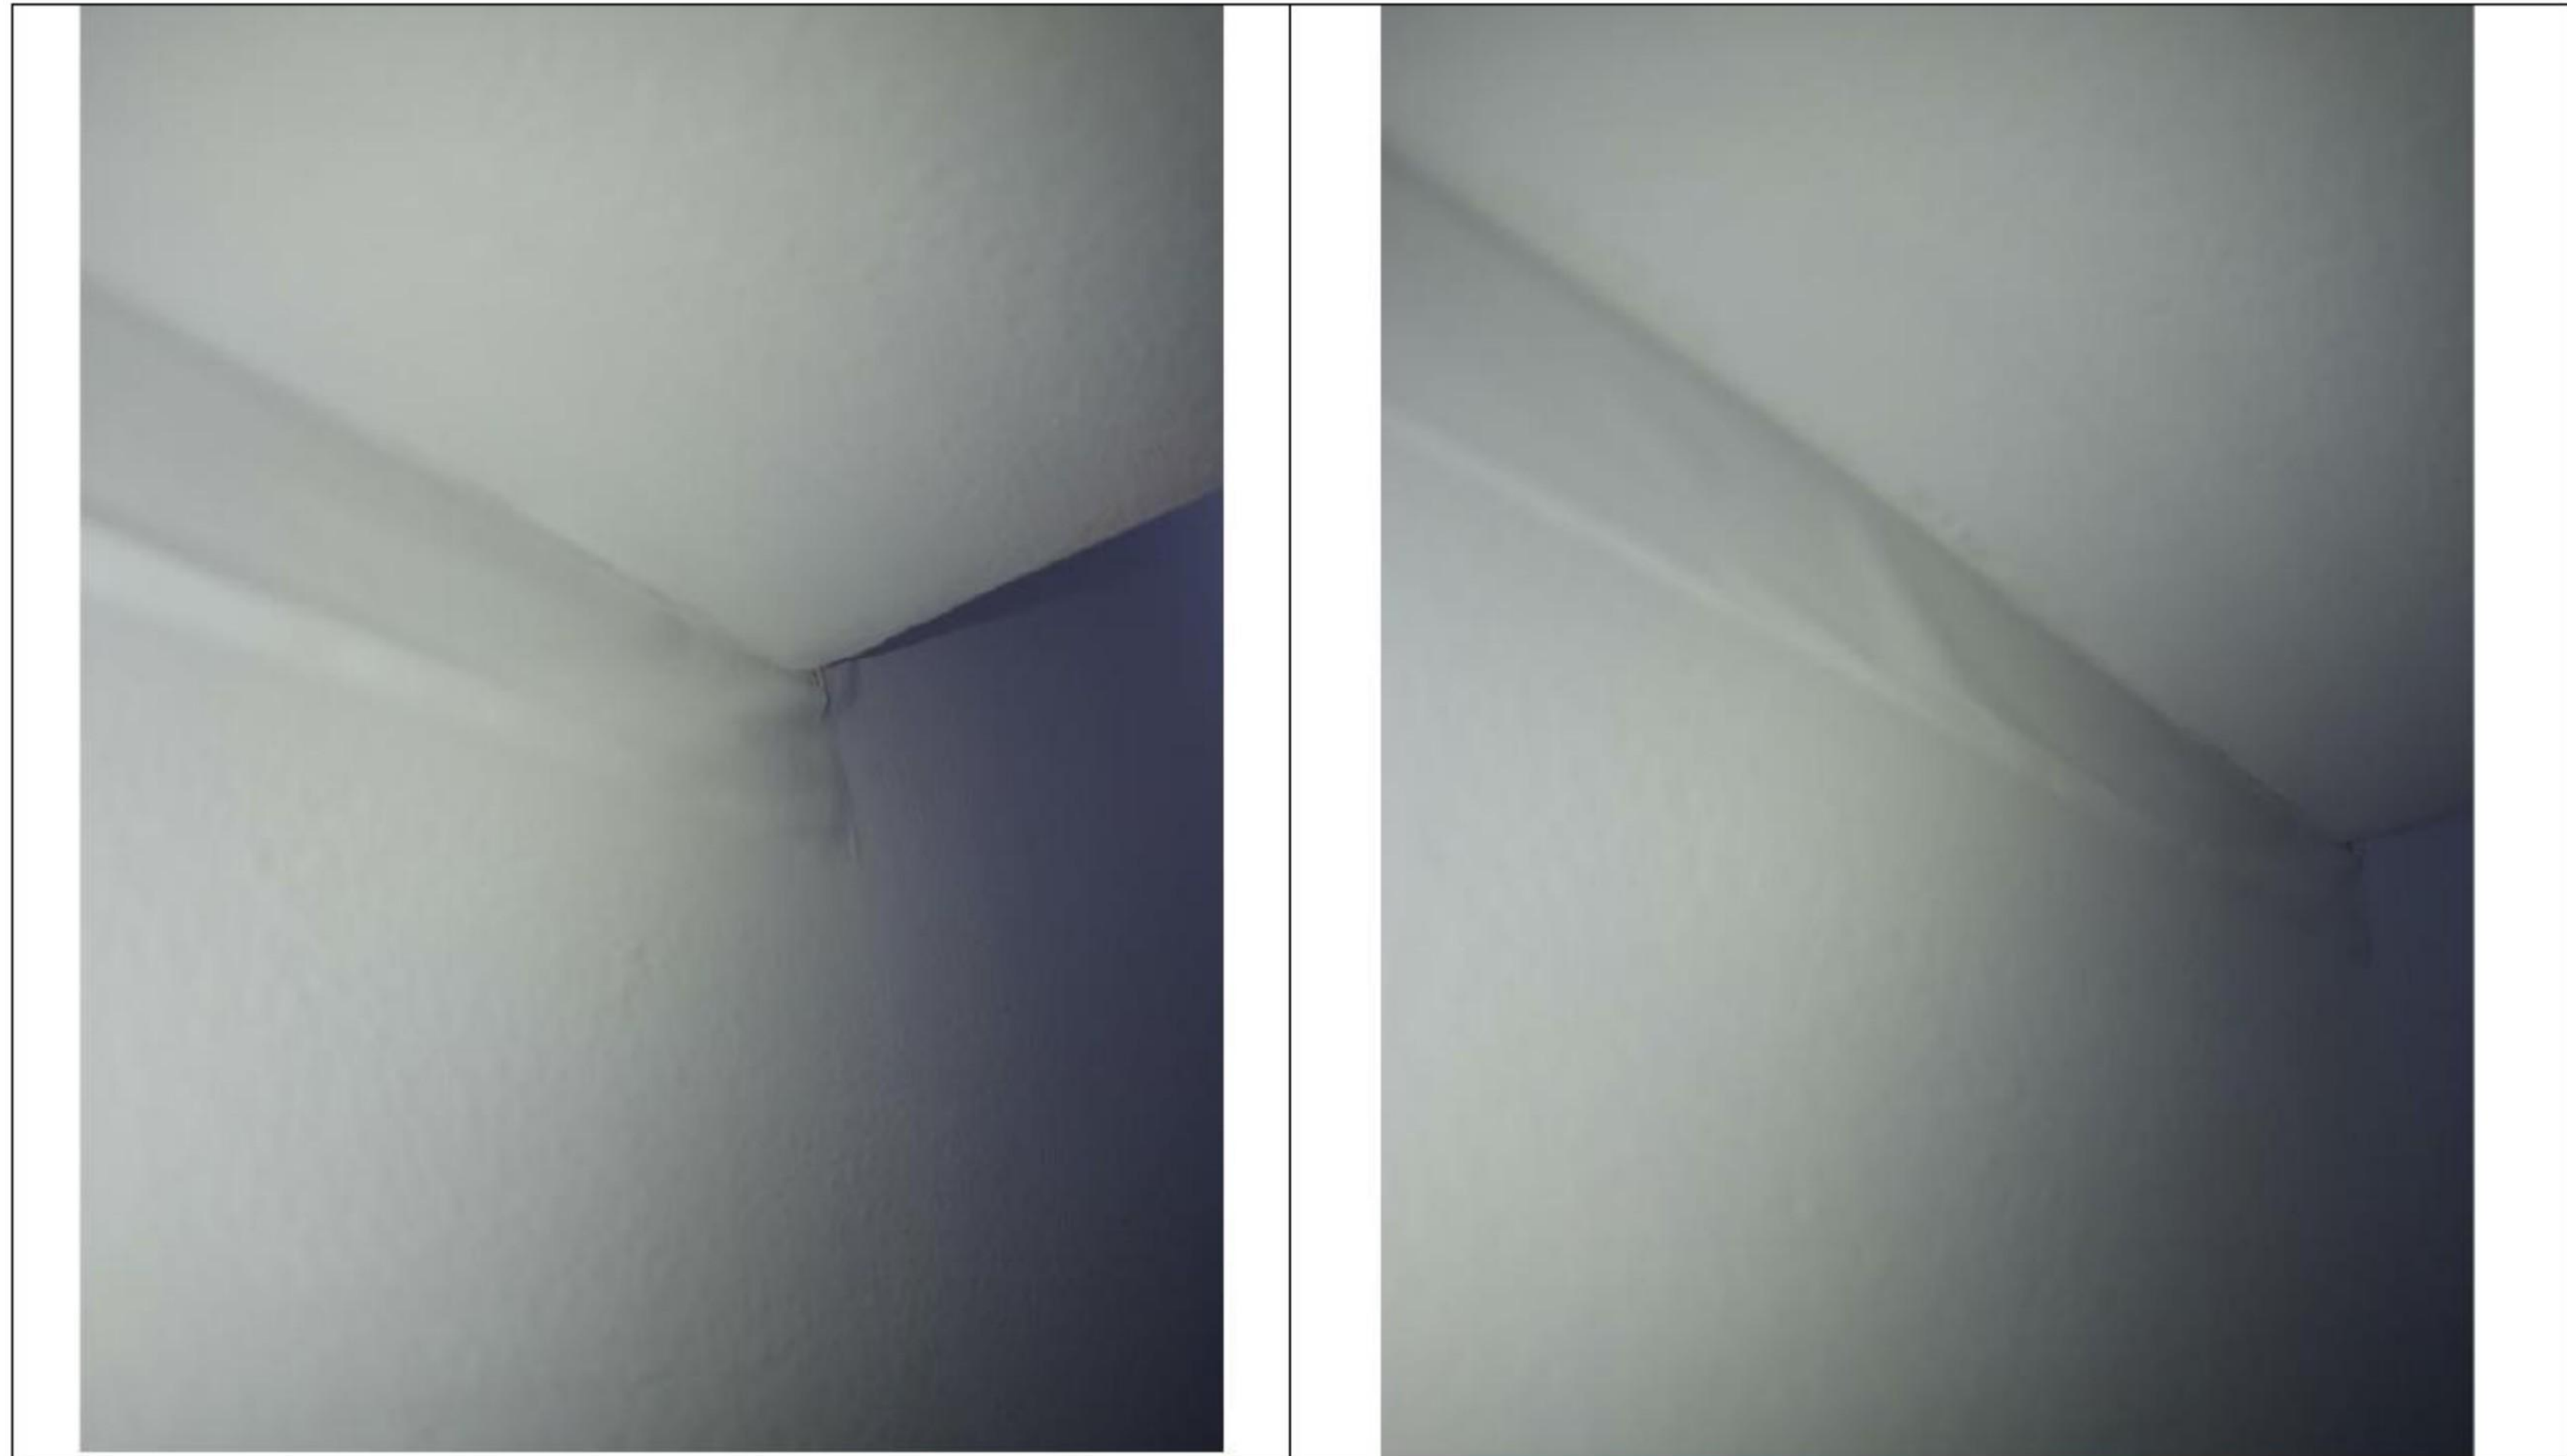
- Inside of the home-office area:

Moisture ingress was observed at three locations within the property. Evidence of moisture leakage was identified at the front of the office area, within the office, and at the side entrance.

The active moisture ingress was observed at three separate locations throughout the building during rainfall. The pattern of moisture staining and leakage indicates that the source is likely associated with the roof structure above. In addition, mould growth was observed on one of the exposed timber framing members, indicating prolonged exposure to moisture.

- Engage a suitably qualified roofing contractor to inspect the roof structure, identify the source of the moisture ingress, and undertake the necessary rectification works to eliminate the leak in accordance with the relevant Australian Standards and the manufacturer's installation requirements.

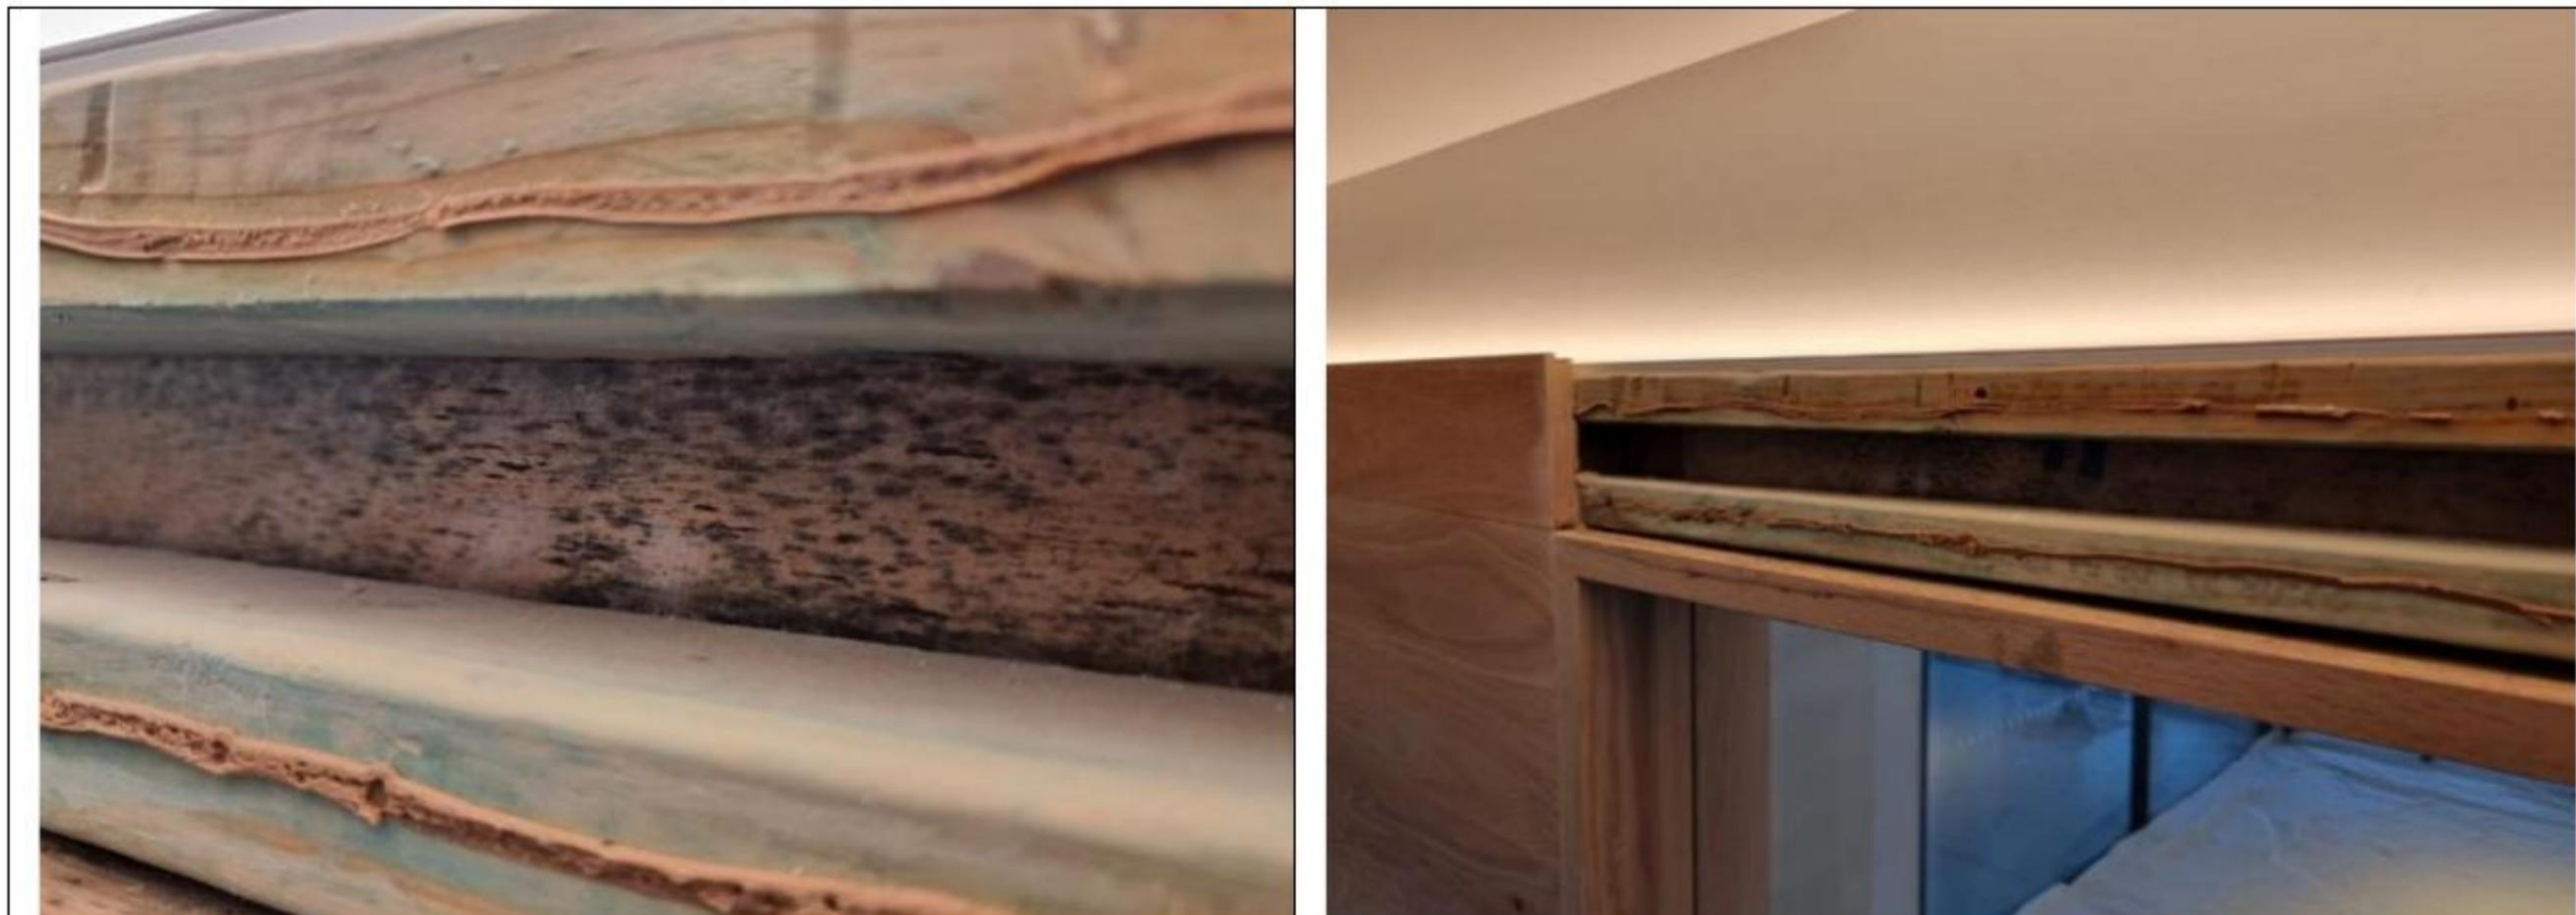
The timber framing at the entrance to the office area had been partially removed to facilitate inspection. Evidence of mould growth was observed on the exposed timber members. At the time of inspection, it could not be confirmed whether the timber had been treated for resistance to moisture exposure.

At the time of inspection, it could not be confirmed whether the affected timber members had been preservative-treated. Reference to **AS 1604.1:2012 – Specification for Preservative Treatment** may assist in identifying the required hazard class (e.g. H1, H2 or H3) for the timber and determining whether the installed material is suitable for its service environment.

- Once the leak has been rectified and the affected area has dried, inspect the damaged timber members to determine the timber type and whether preservative treatment has been applied.

- If the affected timber is untreated and has sustained moisture-related deterioration, replace the damaged timber members on a like-for-like basis to restore the structural integrity and intended load-carrying capacity of the affected framing.

- If the timber is preservative-treated (e.g. H2 or higher), assess whether the mould is limited to surface growth or whether prolonged moisture exposure has resulted in fungal decay or loss of structural integrity. Replace any timber members that are found to have significant decay or compromised structural capacity.

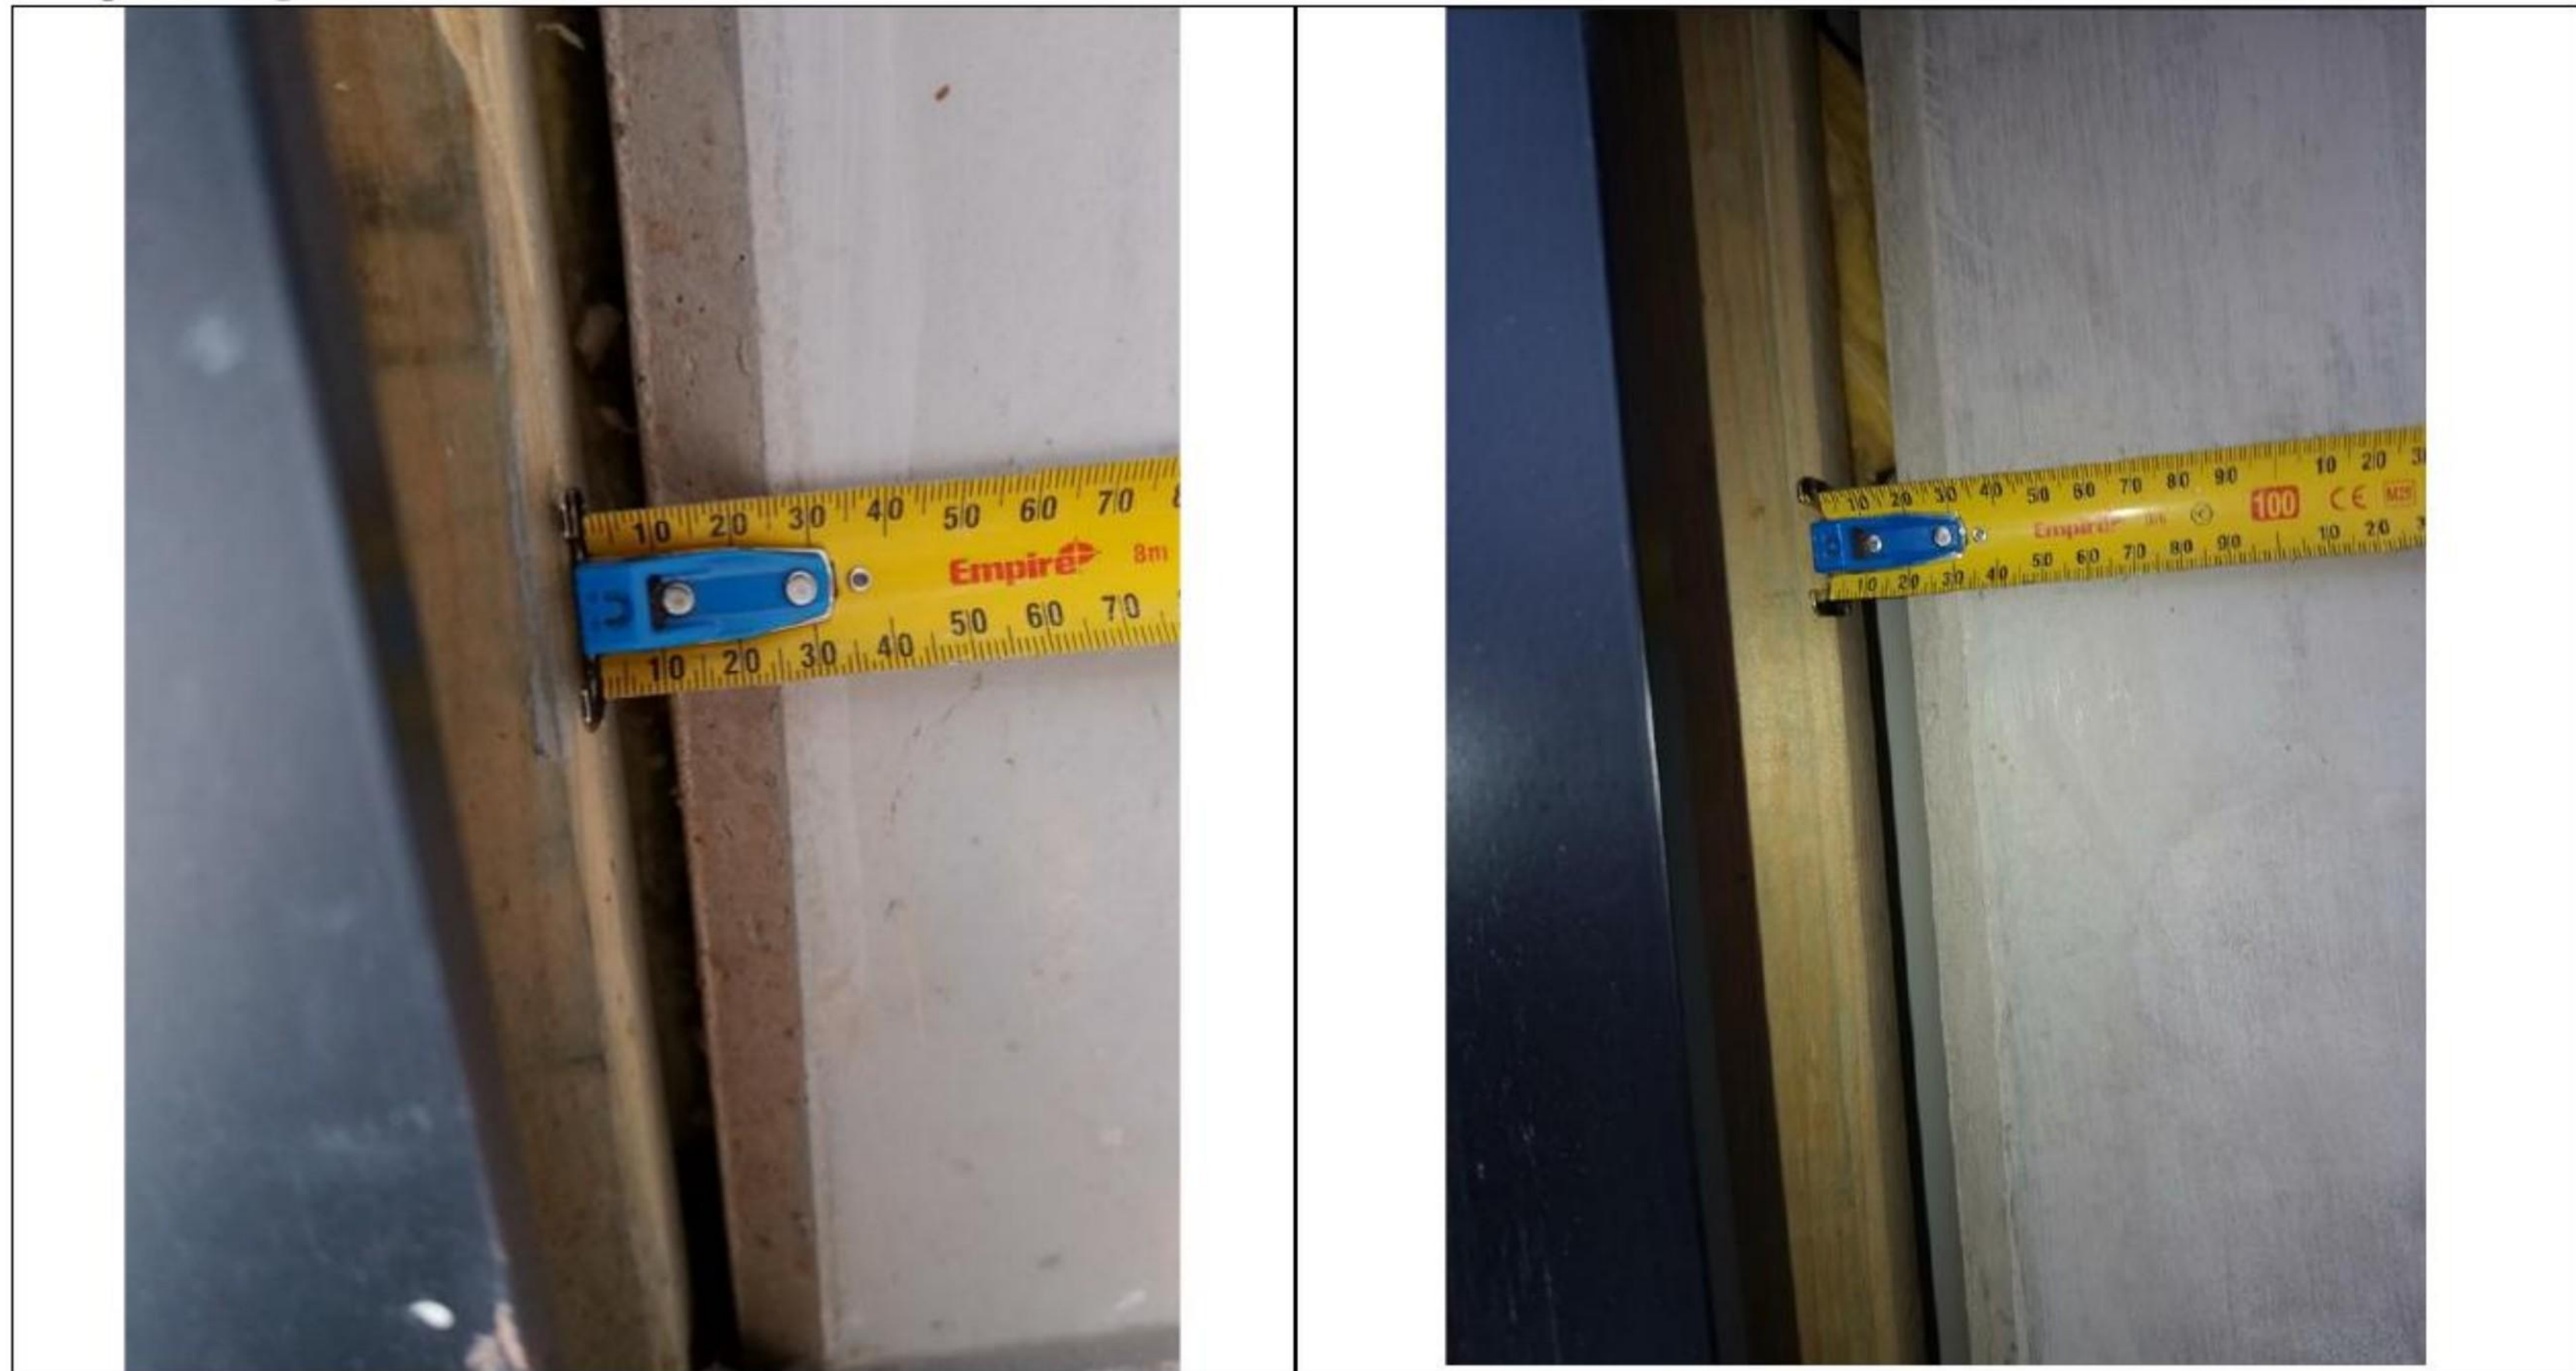
The concrete wall located on the West side of the property show sign of leaning and out of plumbs approximately 10mm from the bottom to top.

The concrete wall located on the eastern side of the property was observed to be out of plumb by approximately 10–15 mm, measured from the base of the wall to the ceiling level at the ground floor. The original structural documentation was not available at the time of inspection to confirm whether the wall is reinforced concrete or unreinforced masonry.

No cracking or bulging were observed on the wall surface at the time of inspection.

Continue to monitor the wall for 12 months to identify any increase in out-of-plumb, cracking, or other signs of movement. If further movement is observed, engage a structural engineer to investigate the underlying cause and determine whether foundation stabilisation, additional structural restraint, or masonry rectification works are required.

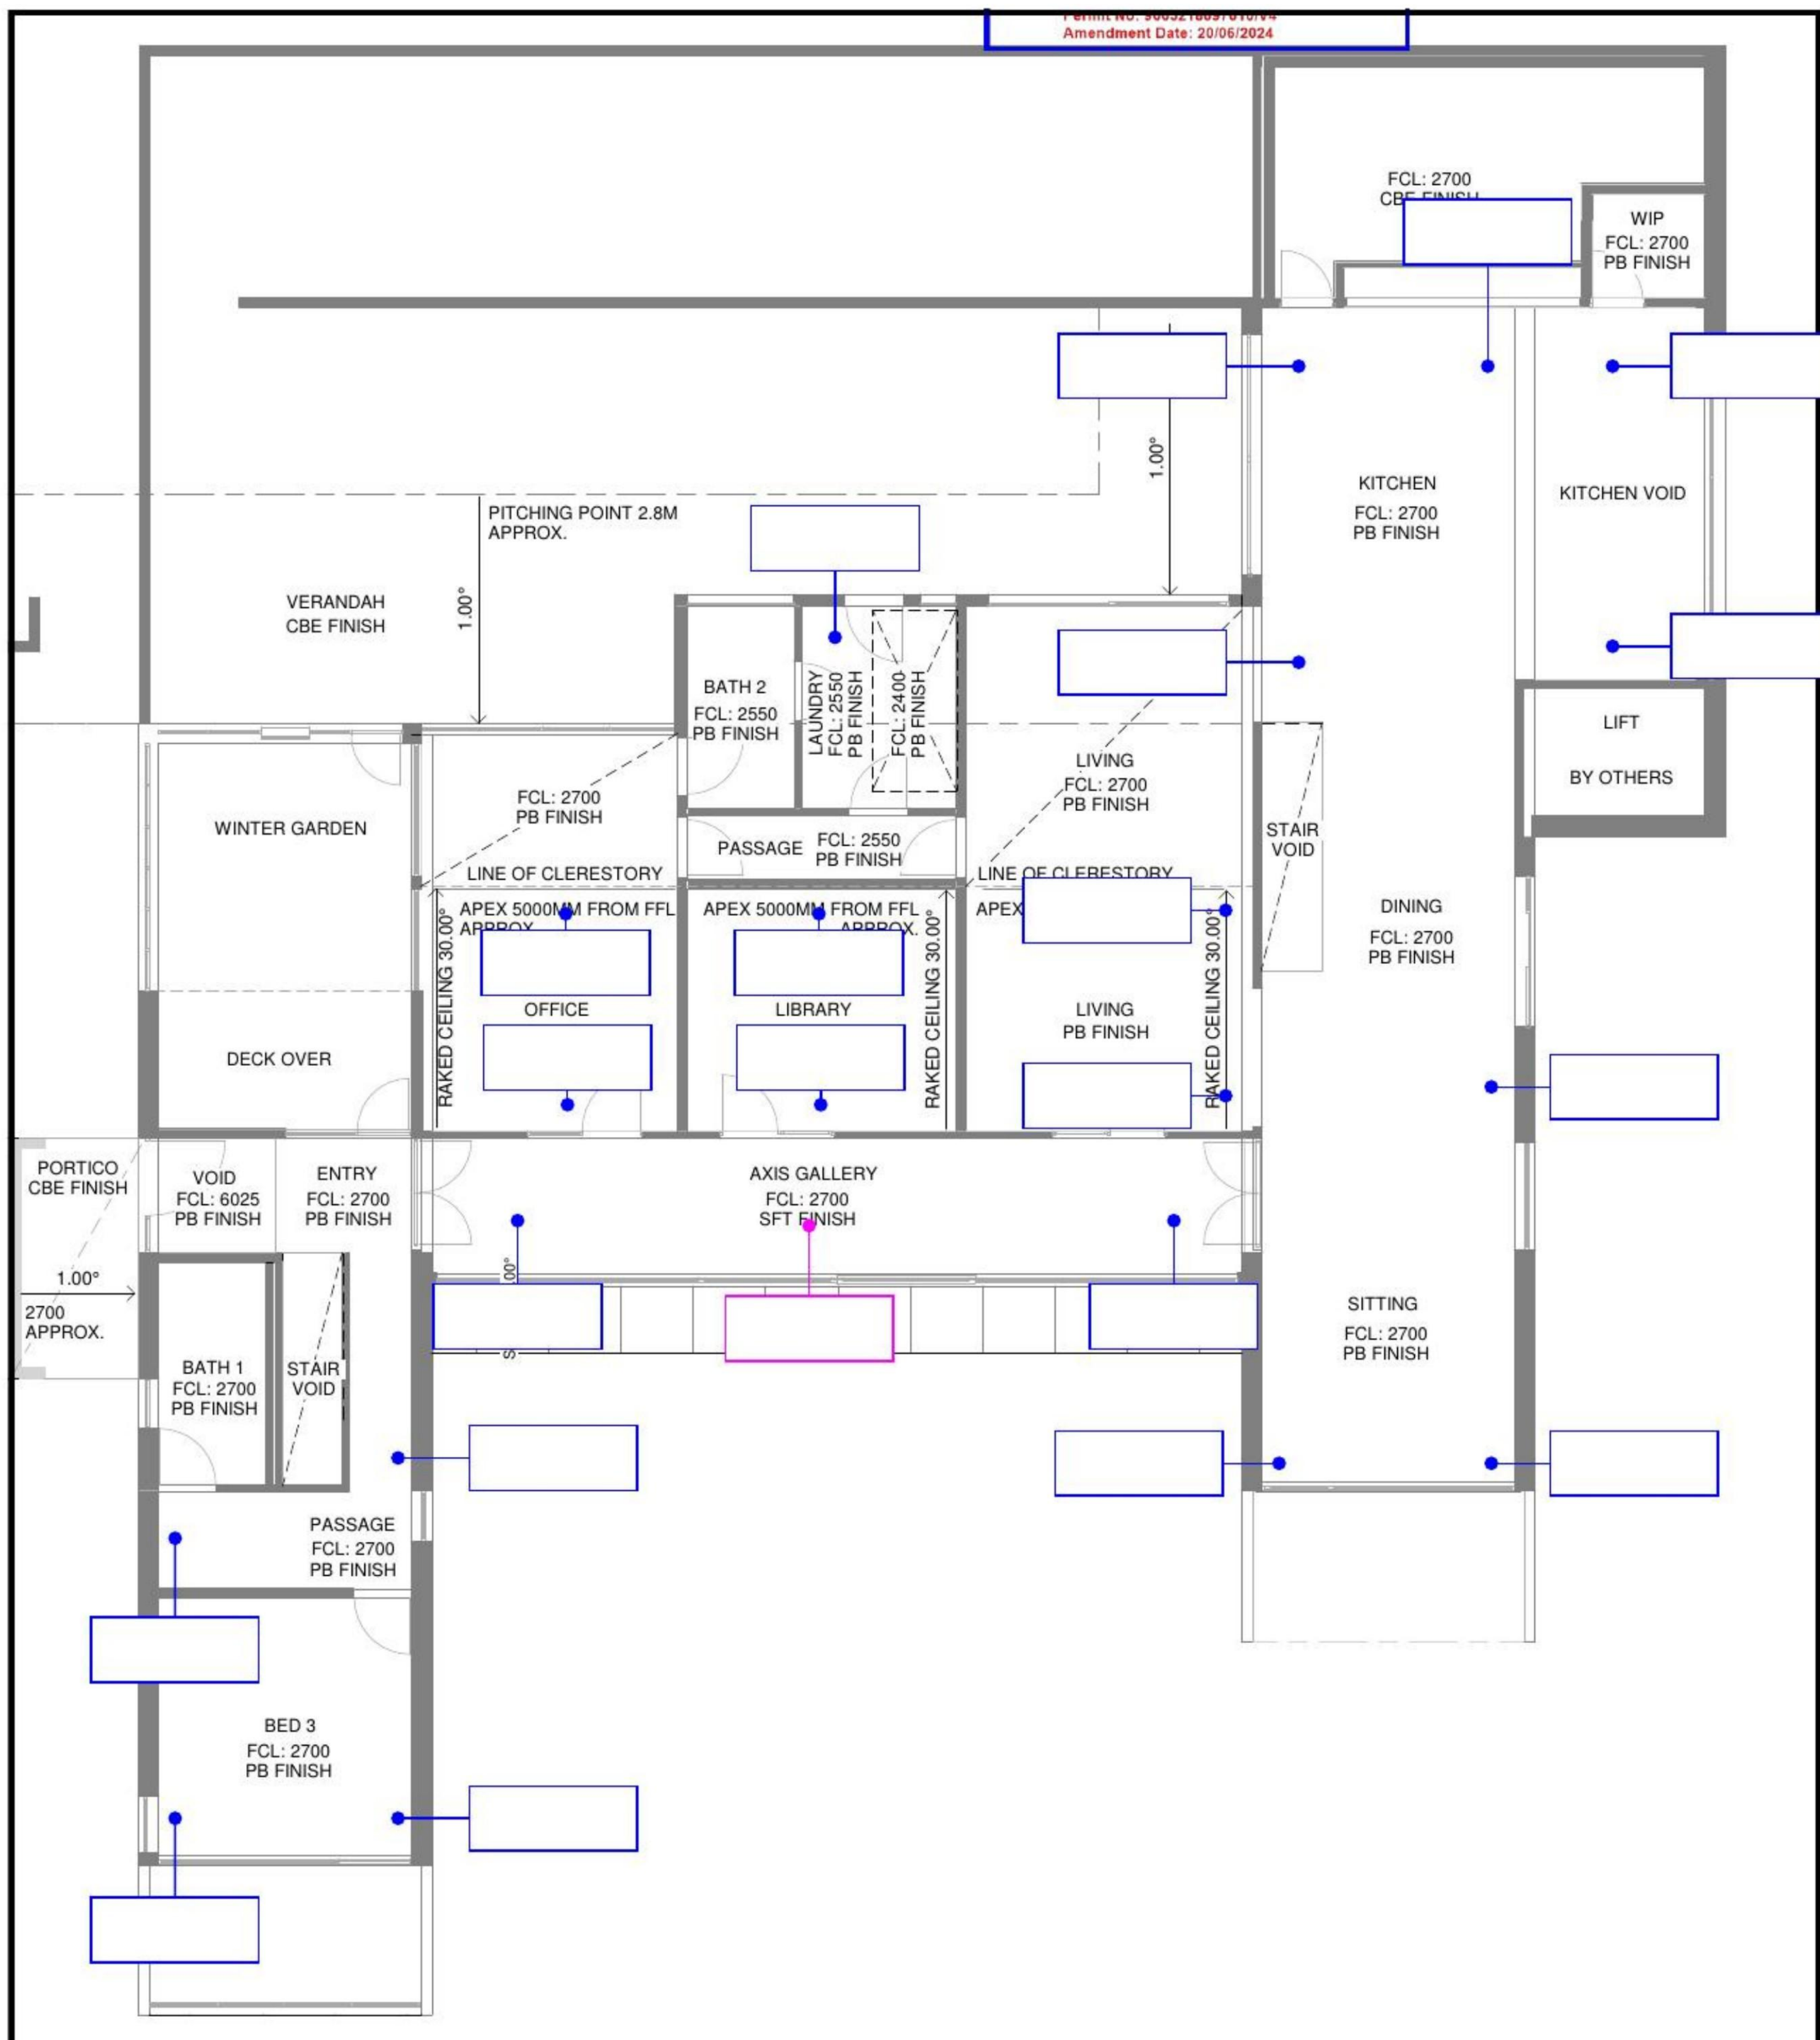
- First Floor:

- **Floor Structure:** Floor level measurements identified maximum slab deviations of approximately 8 mm over a 3 m span, classified as Negligible to Very Slight (Category 0–1) in accordance with AS 2870:2011 Appendix C2. The observed variation is considered within acceptable limits and does not indicate significant differential settlement.

No urgent action is currently required, as the observed defects are considered Negligible to Very Slight.
