# Report on Property Inspection

Engineer's Inspection Report for unit [REDACTED]  
[REDACTED]

Prepared for [REDACTED].

[REDACTED] Rev 1.0  
24/07/2026

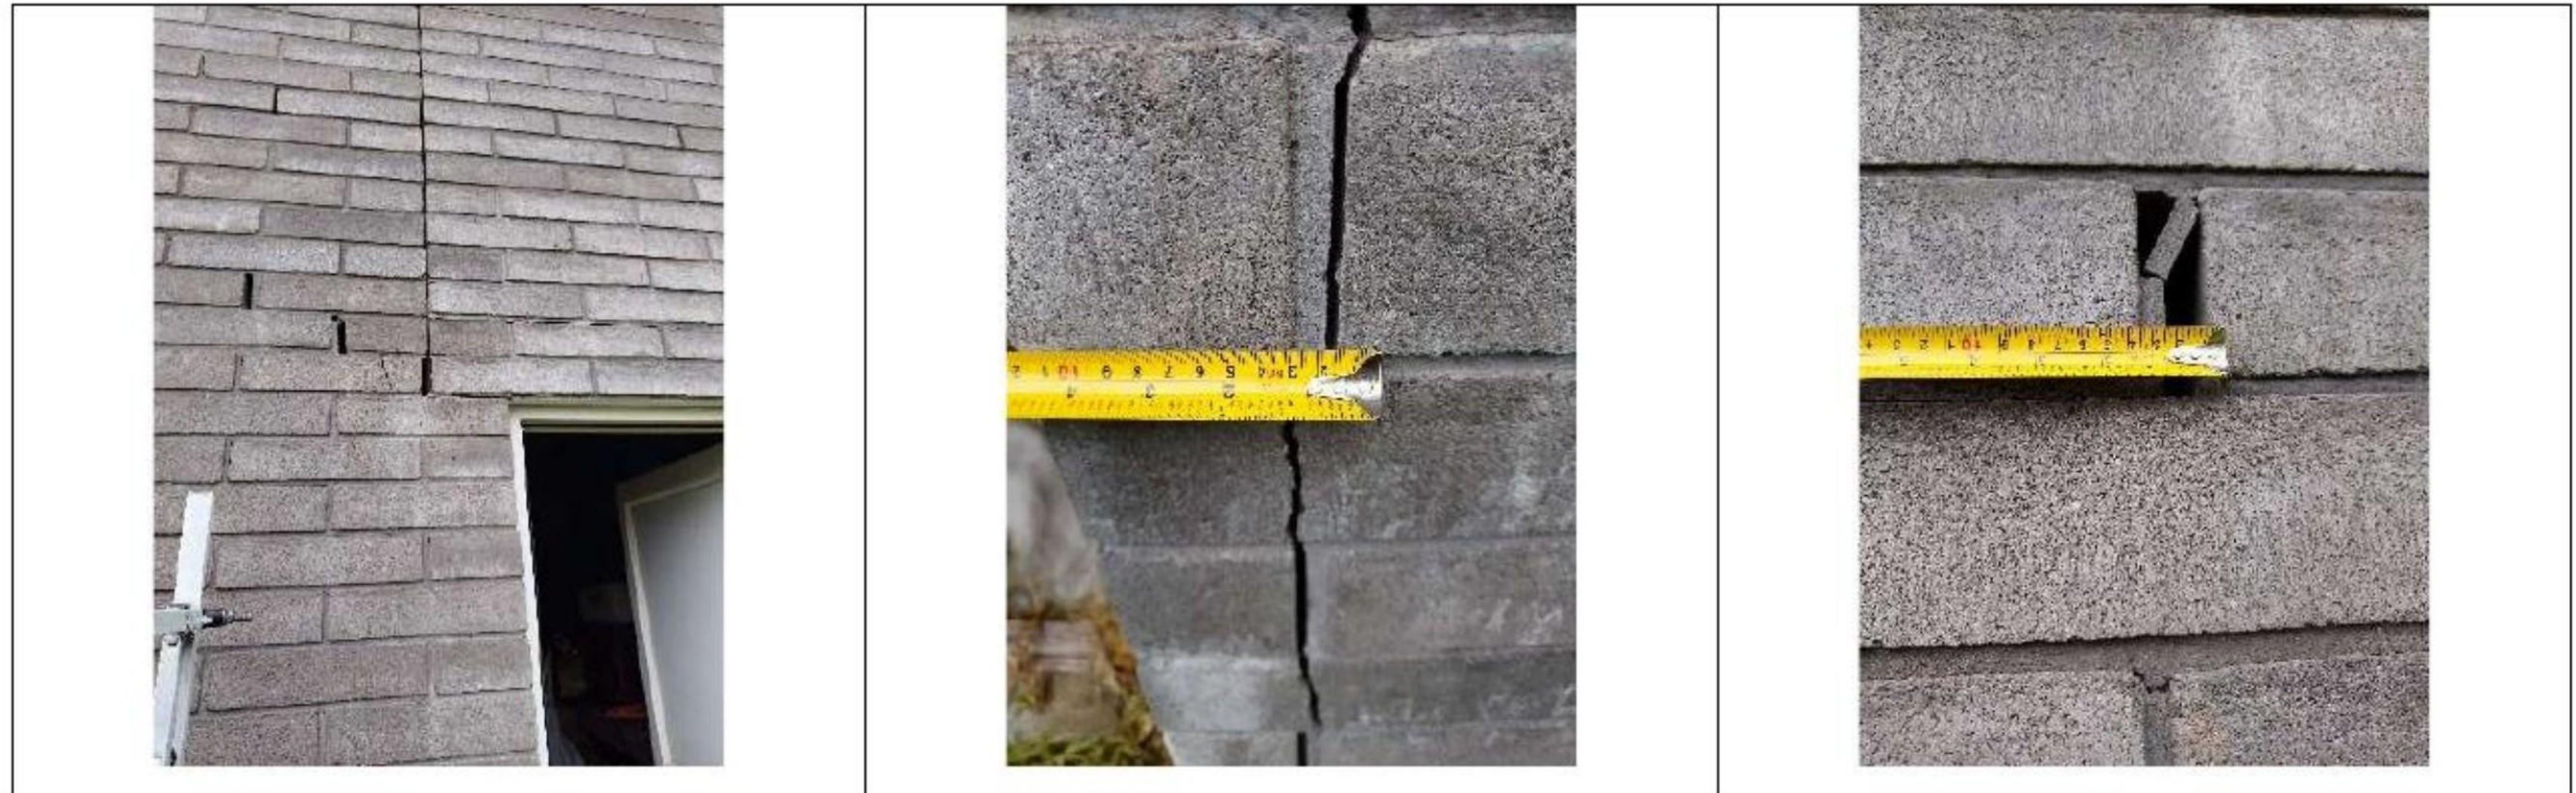
The external wall structure shows signs of displacement, with several cracks ranging from approximately 3 mm to 25 mm in width observed throughout the structure, predominantly on the western and southern perimeter of the property. These cracks presented as both step cracks through the mortar, and as cracking through the bricks.

Cracks of up to 25mm were observed on the external masonry walls around the property, primarily on the western and southern sides of the building.

In accordance with AS 2870:2011, the observed wall damage is classified as **Severe (Category 4)** for the external elements.

It is recommended that a suitably qualified builder or contractor be engaged to inspect the affected area and undertake any necessary sealing or remedial works in accordance with relevant standards.

It is recommended that this rectification work be undertaken after the foundation has stabilised following remediation works.

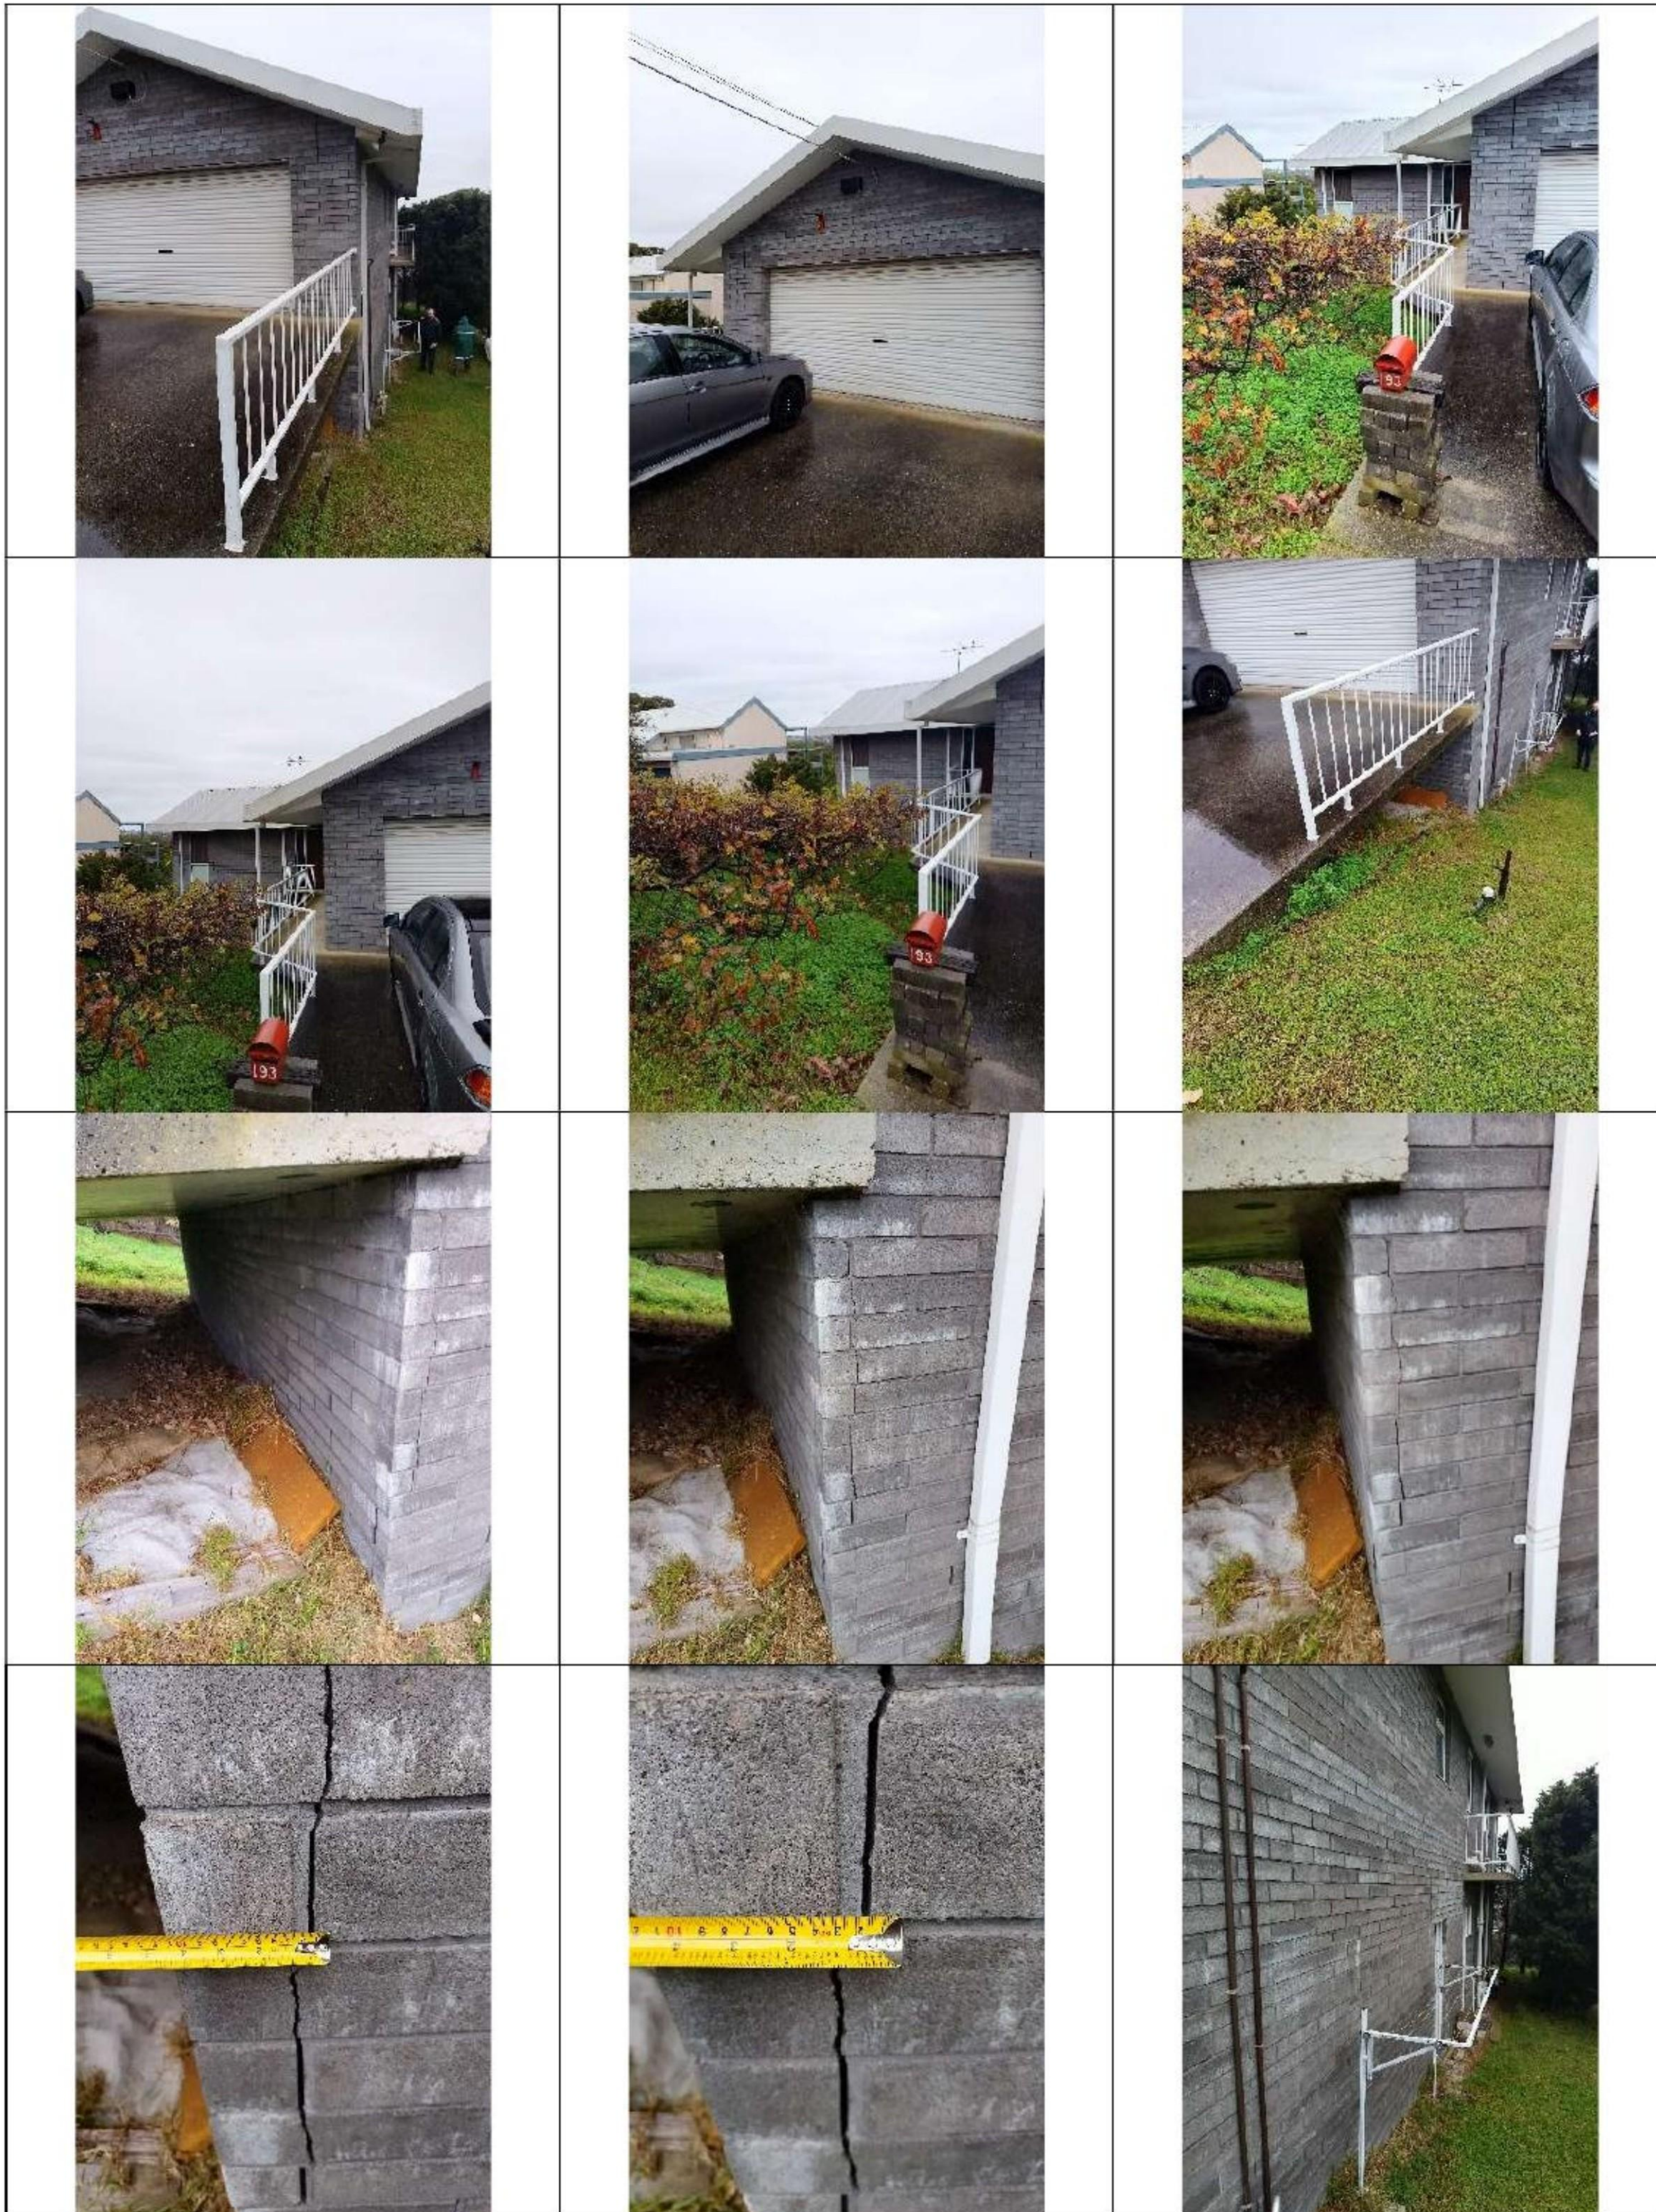
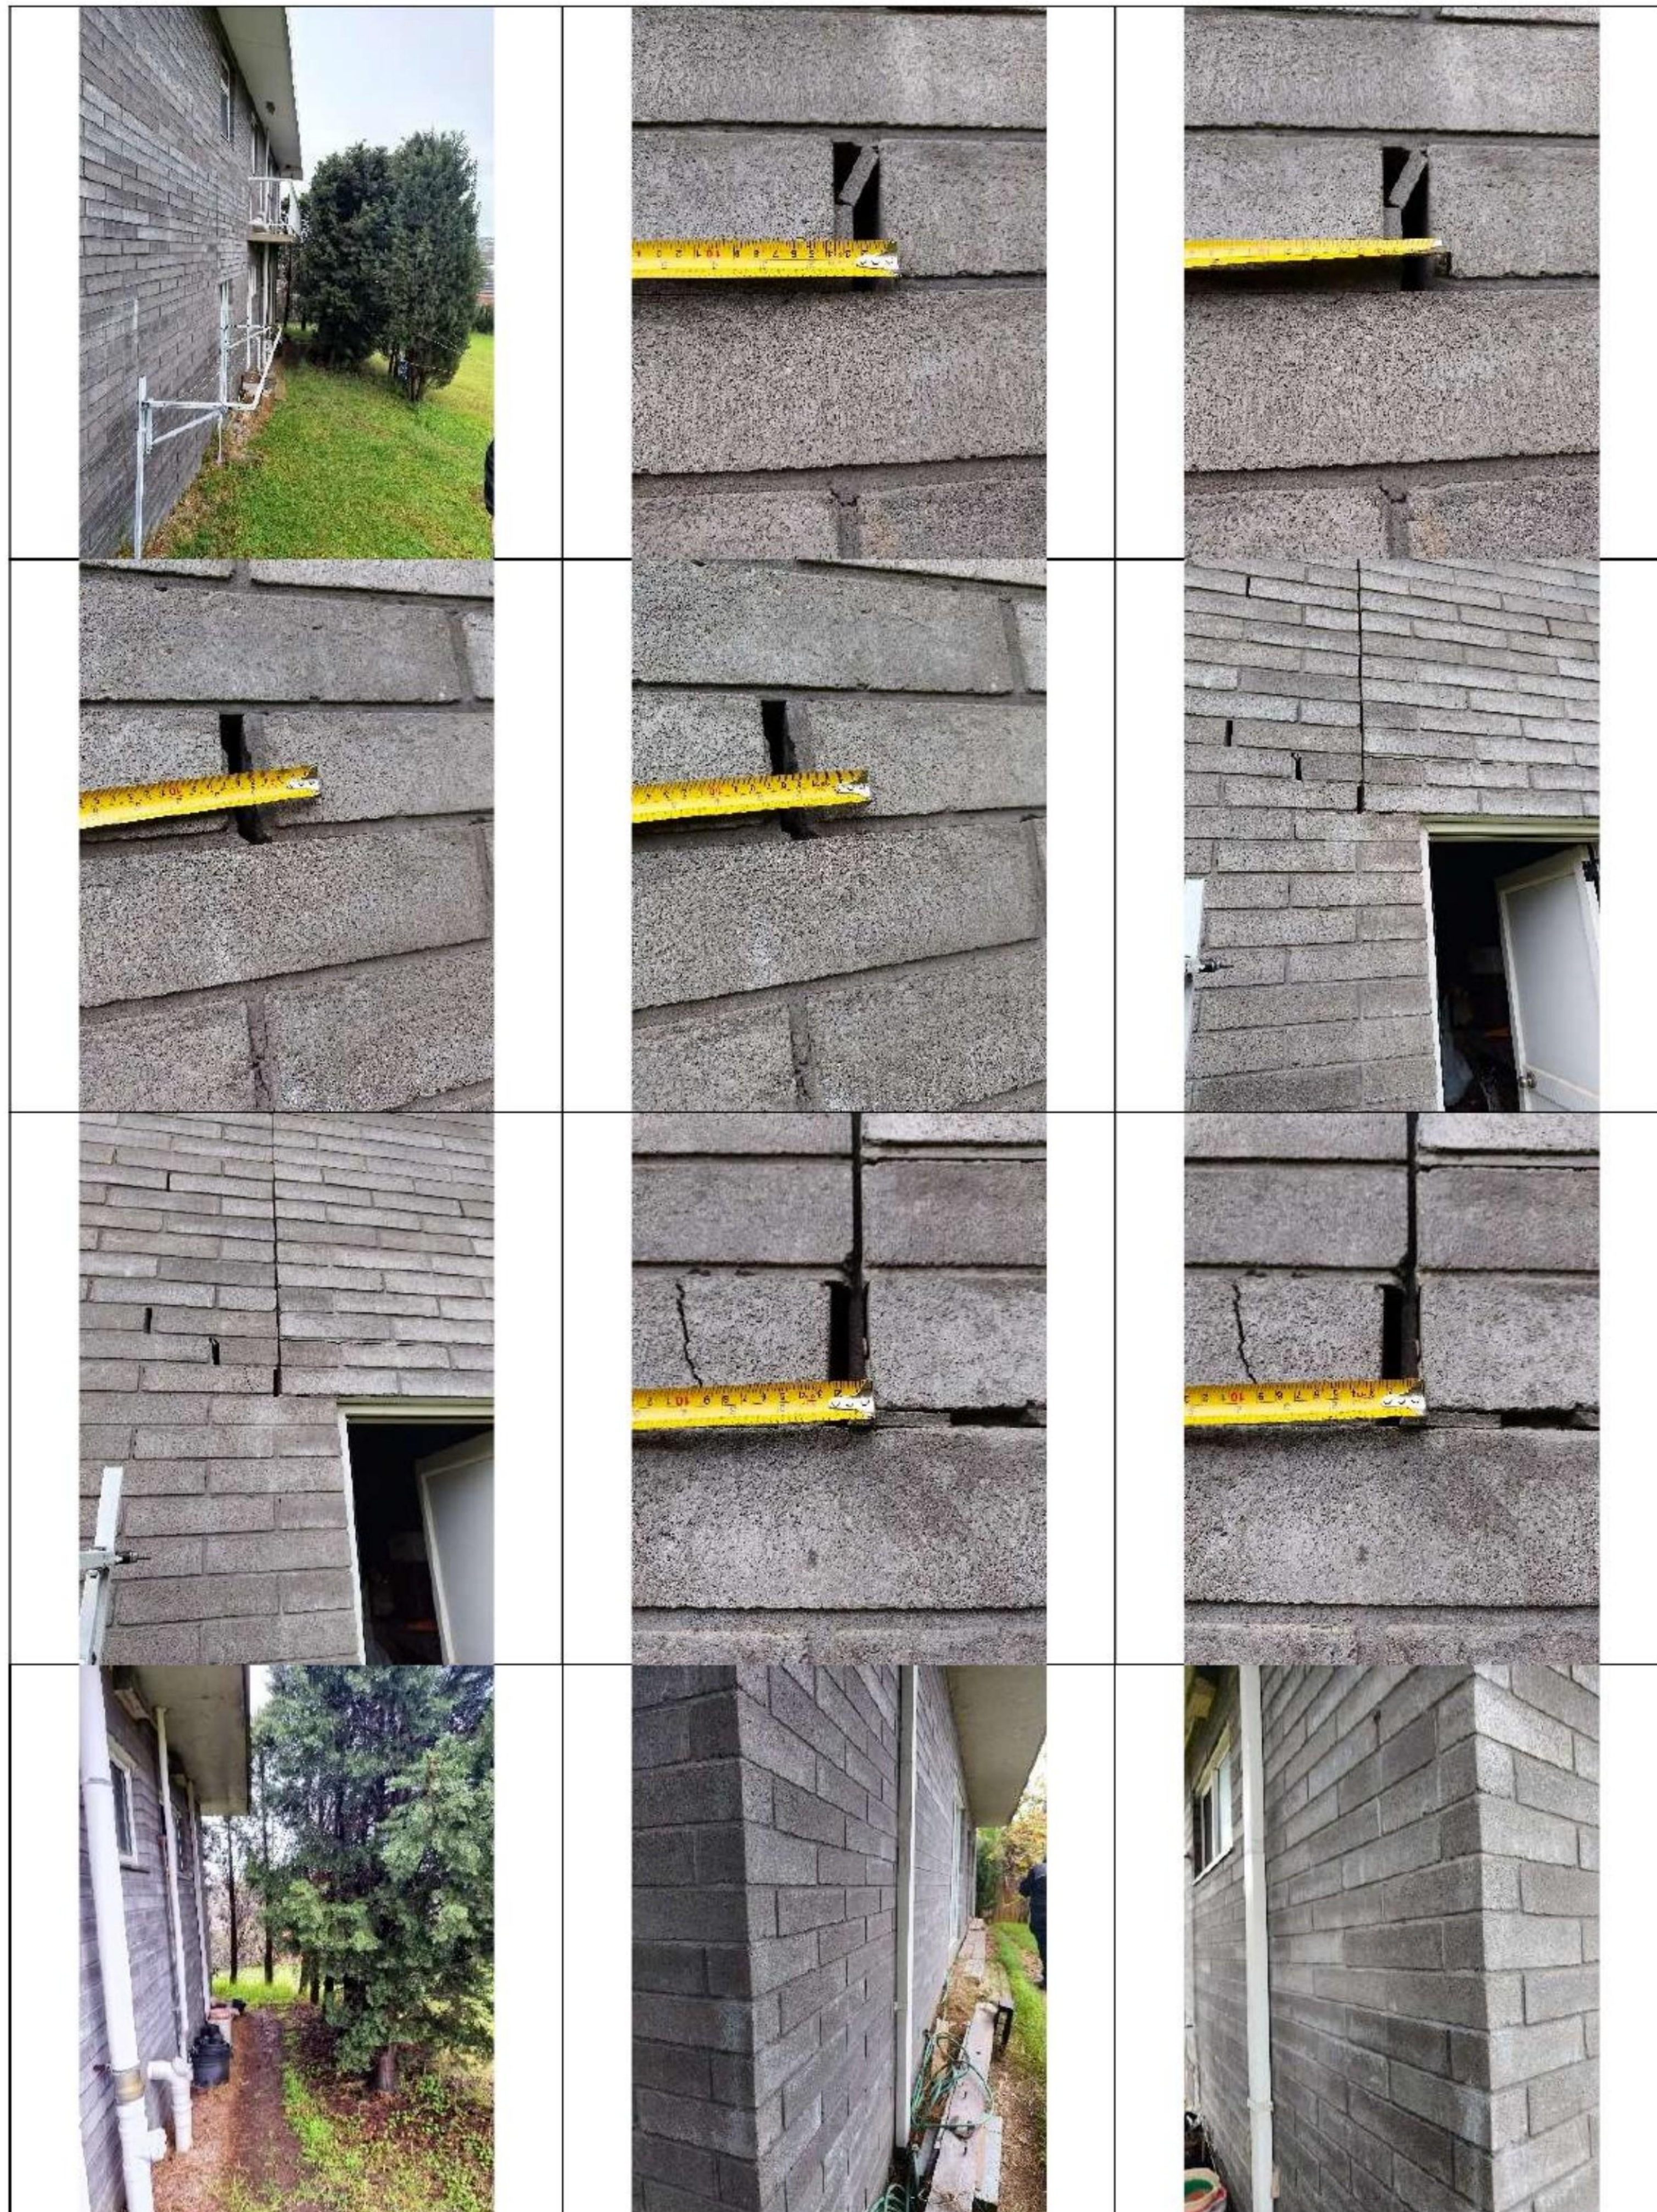
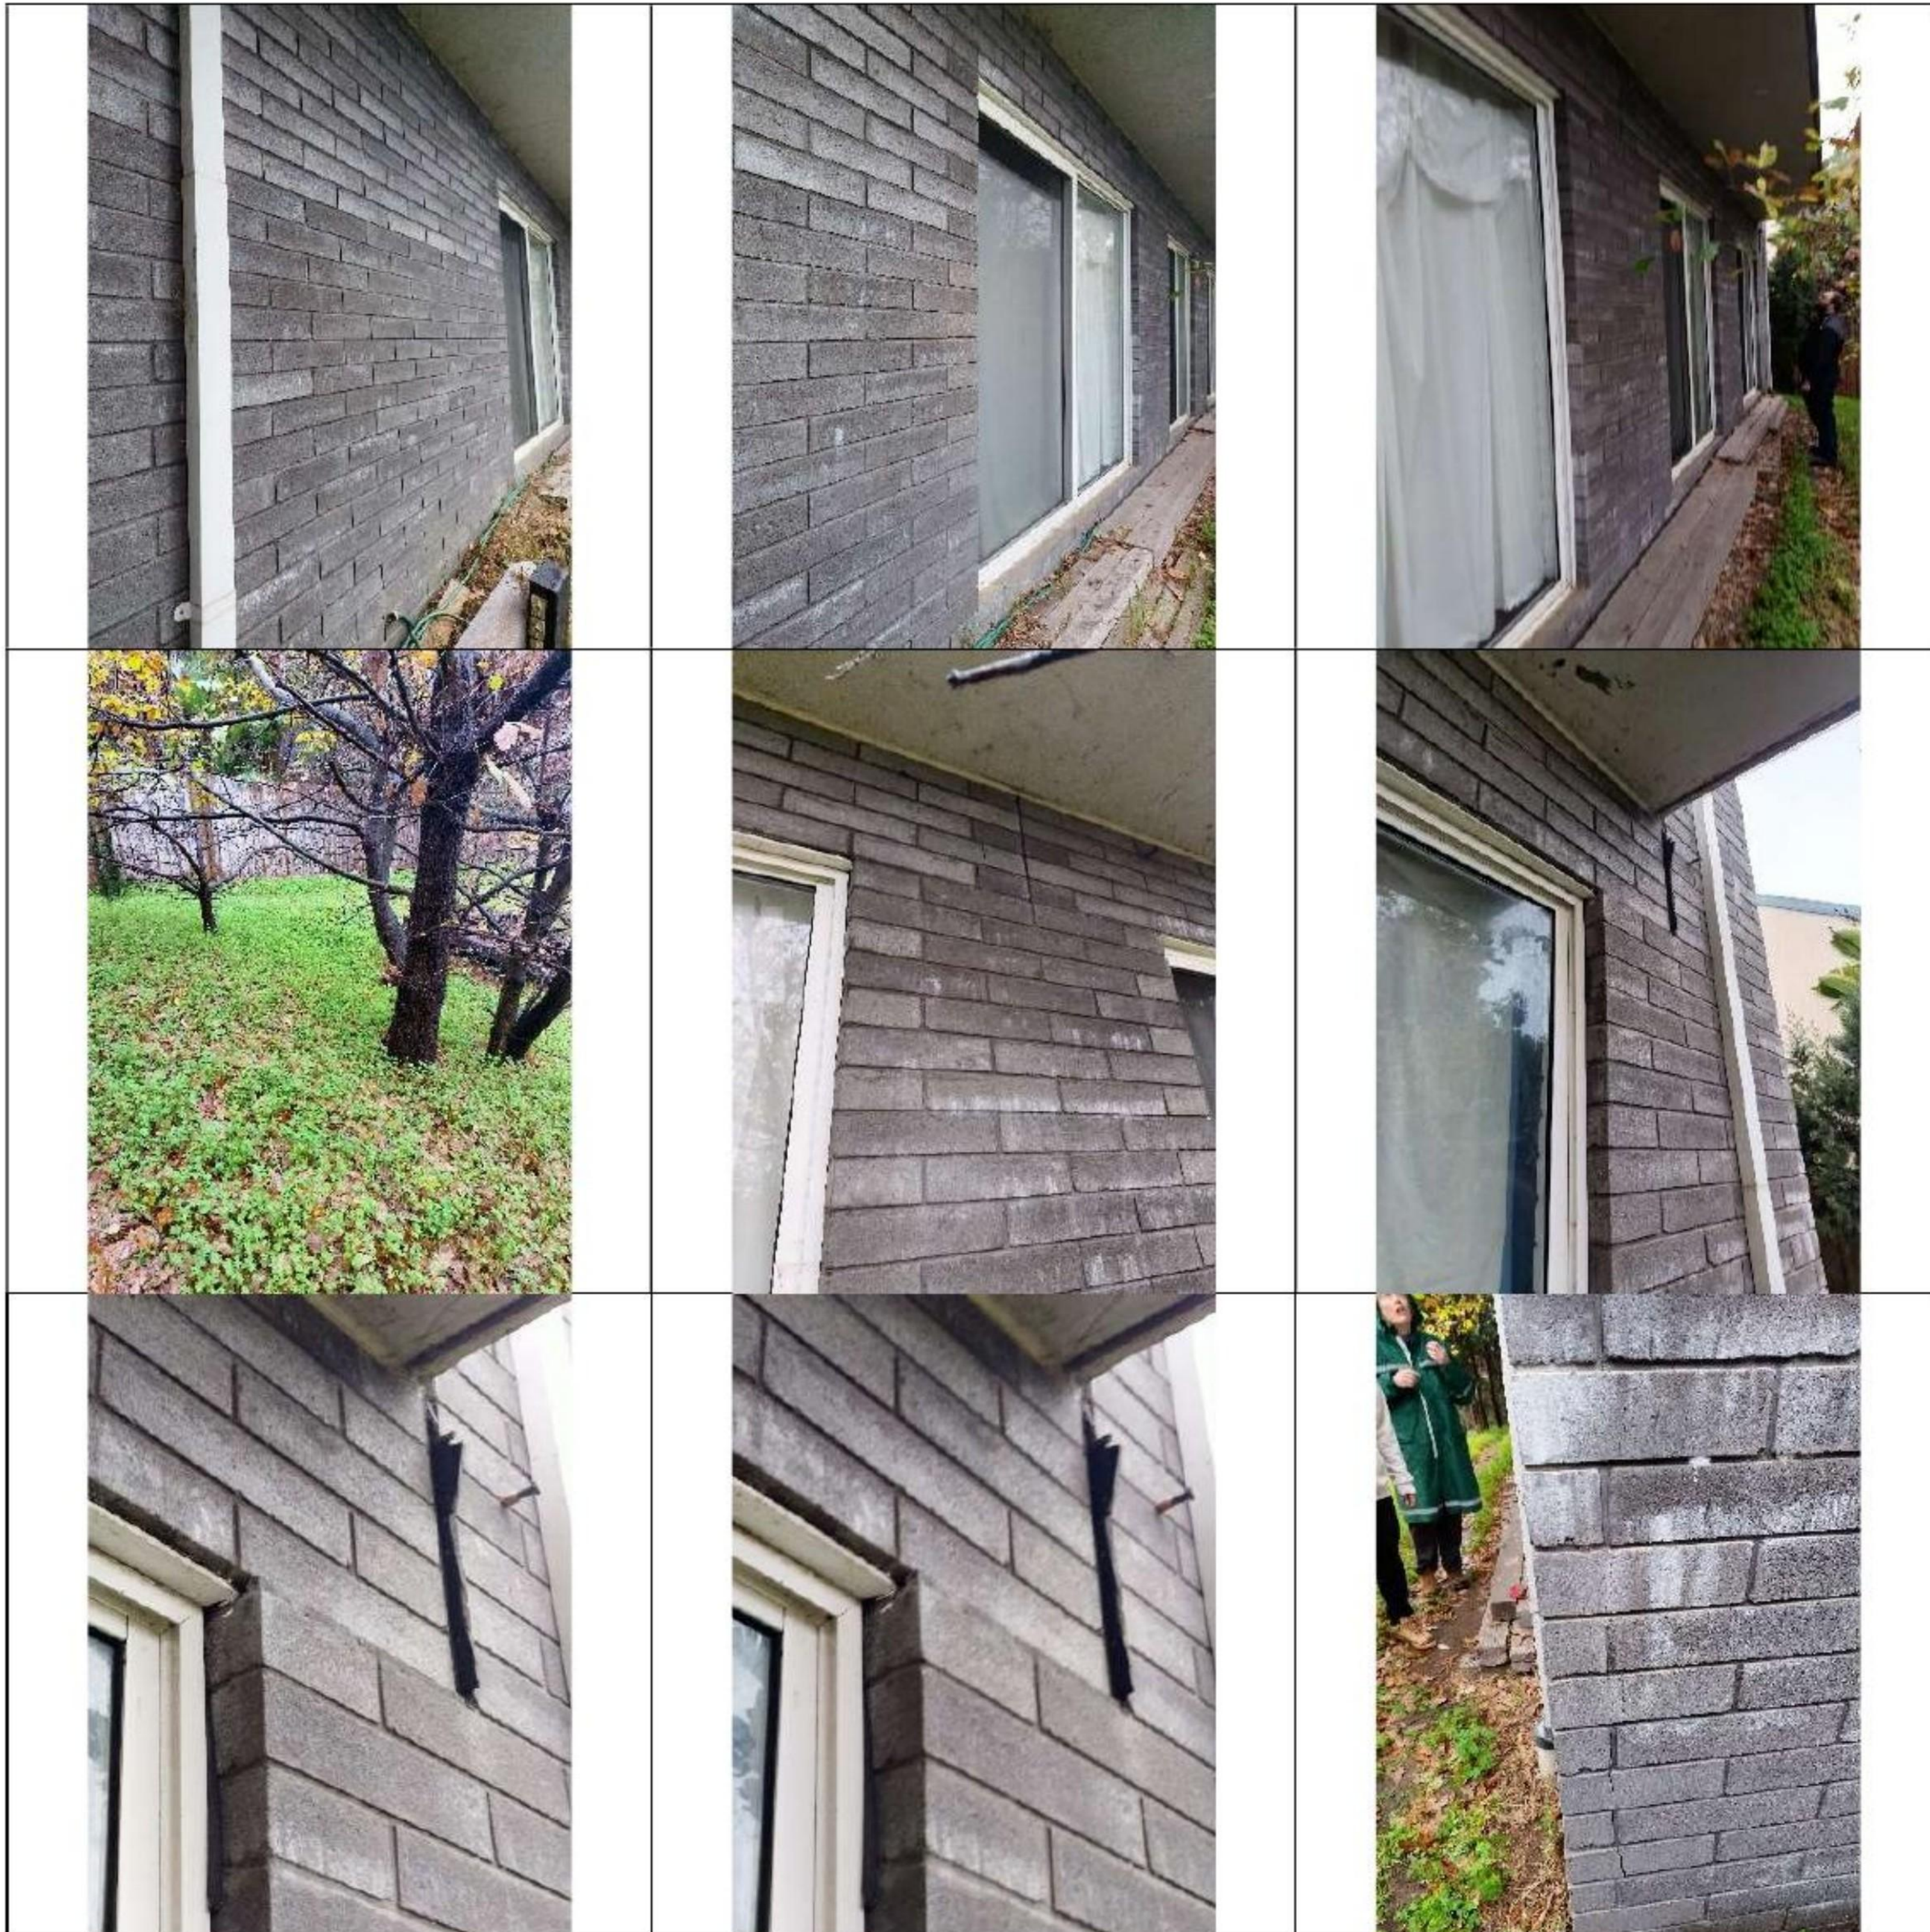
7. Appendix A: Photo Log

Overall observations of the internal wall surfaces reveal the presence of cracks, ranging up to approximately 10mm in width, throughout the building. The cracking on the internal walls is consistent with the floor deviations measured.

Groups of trees up to approximately 5 metres in height were observed at the western, southern, and eastern side of the property, with the closest spacing being approximately 1 metre between the trees and the structure. This proximity may negatively affect the surrounding soil conditions and the building's footings. Tree-induced effects typically occur when roots extend beneath or near the footing system, resulting in moisture variations within the foundation soils.

There is a lack of external drainage or pits around the sides of the property to collect surface moisture and prevent it from entering the footing zone or underlying soils. Without an adequate drainage system, unwanted moisture may infiltrate the natural soil, potentially reduce its bearing capacity and compromise the overall stability of the structure. This condition can lead to footing movement and subsequent structural distress.

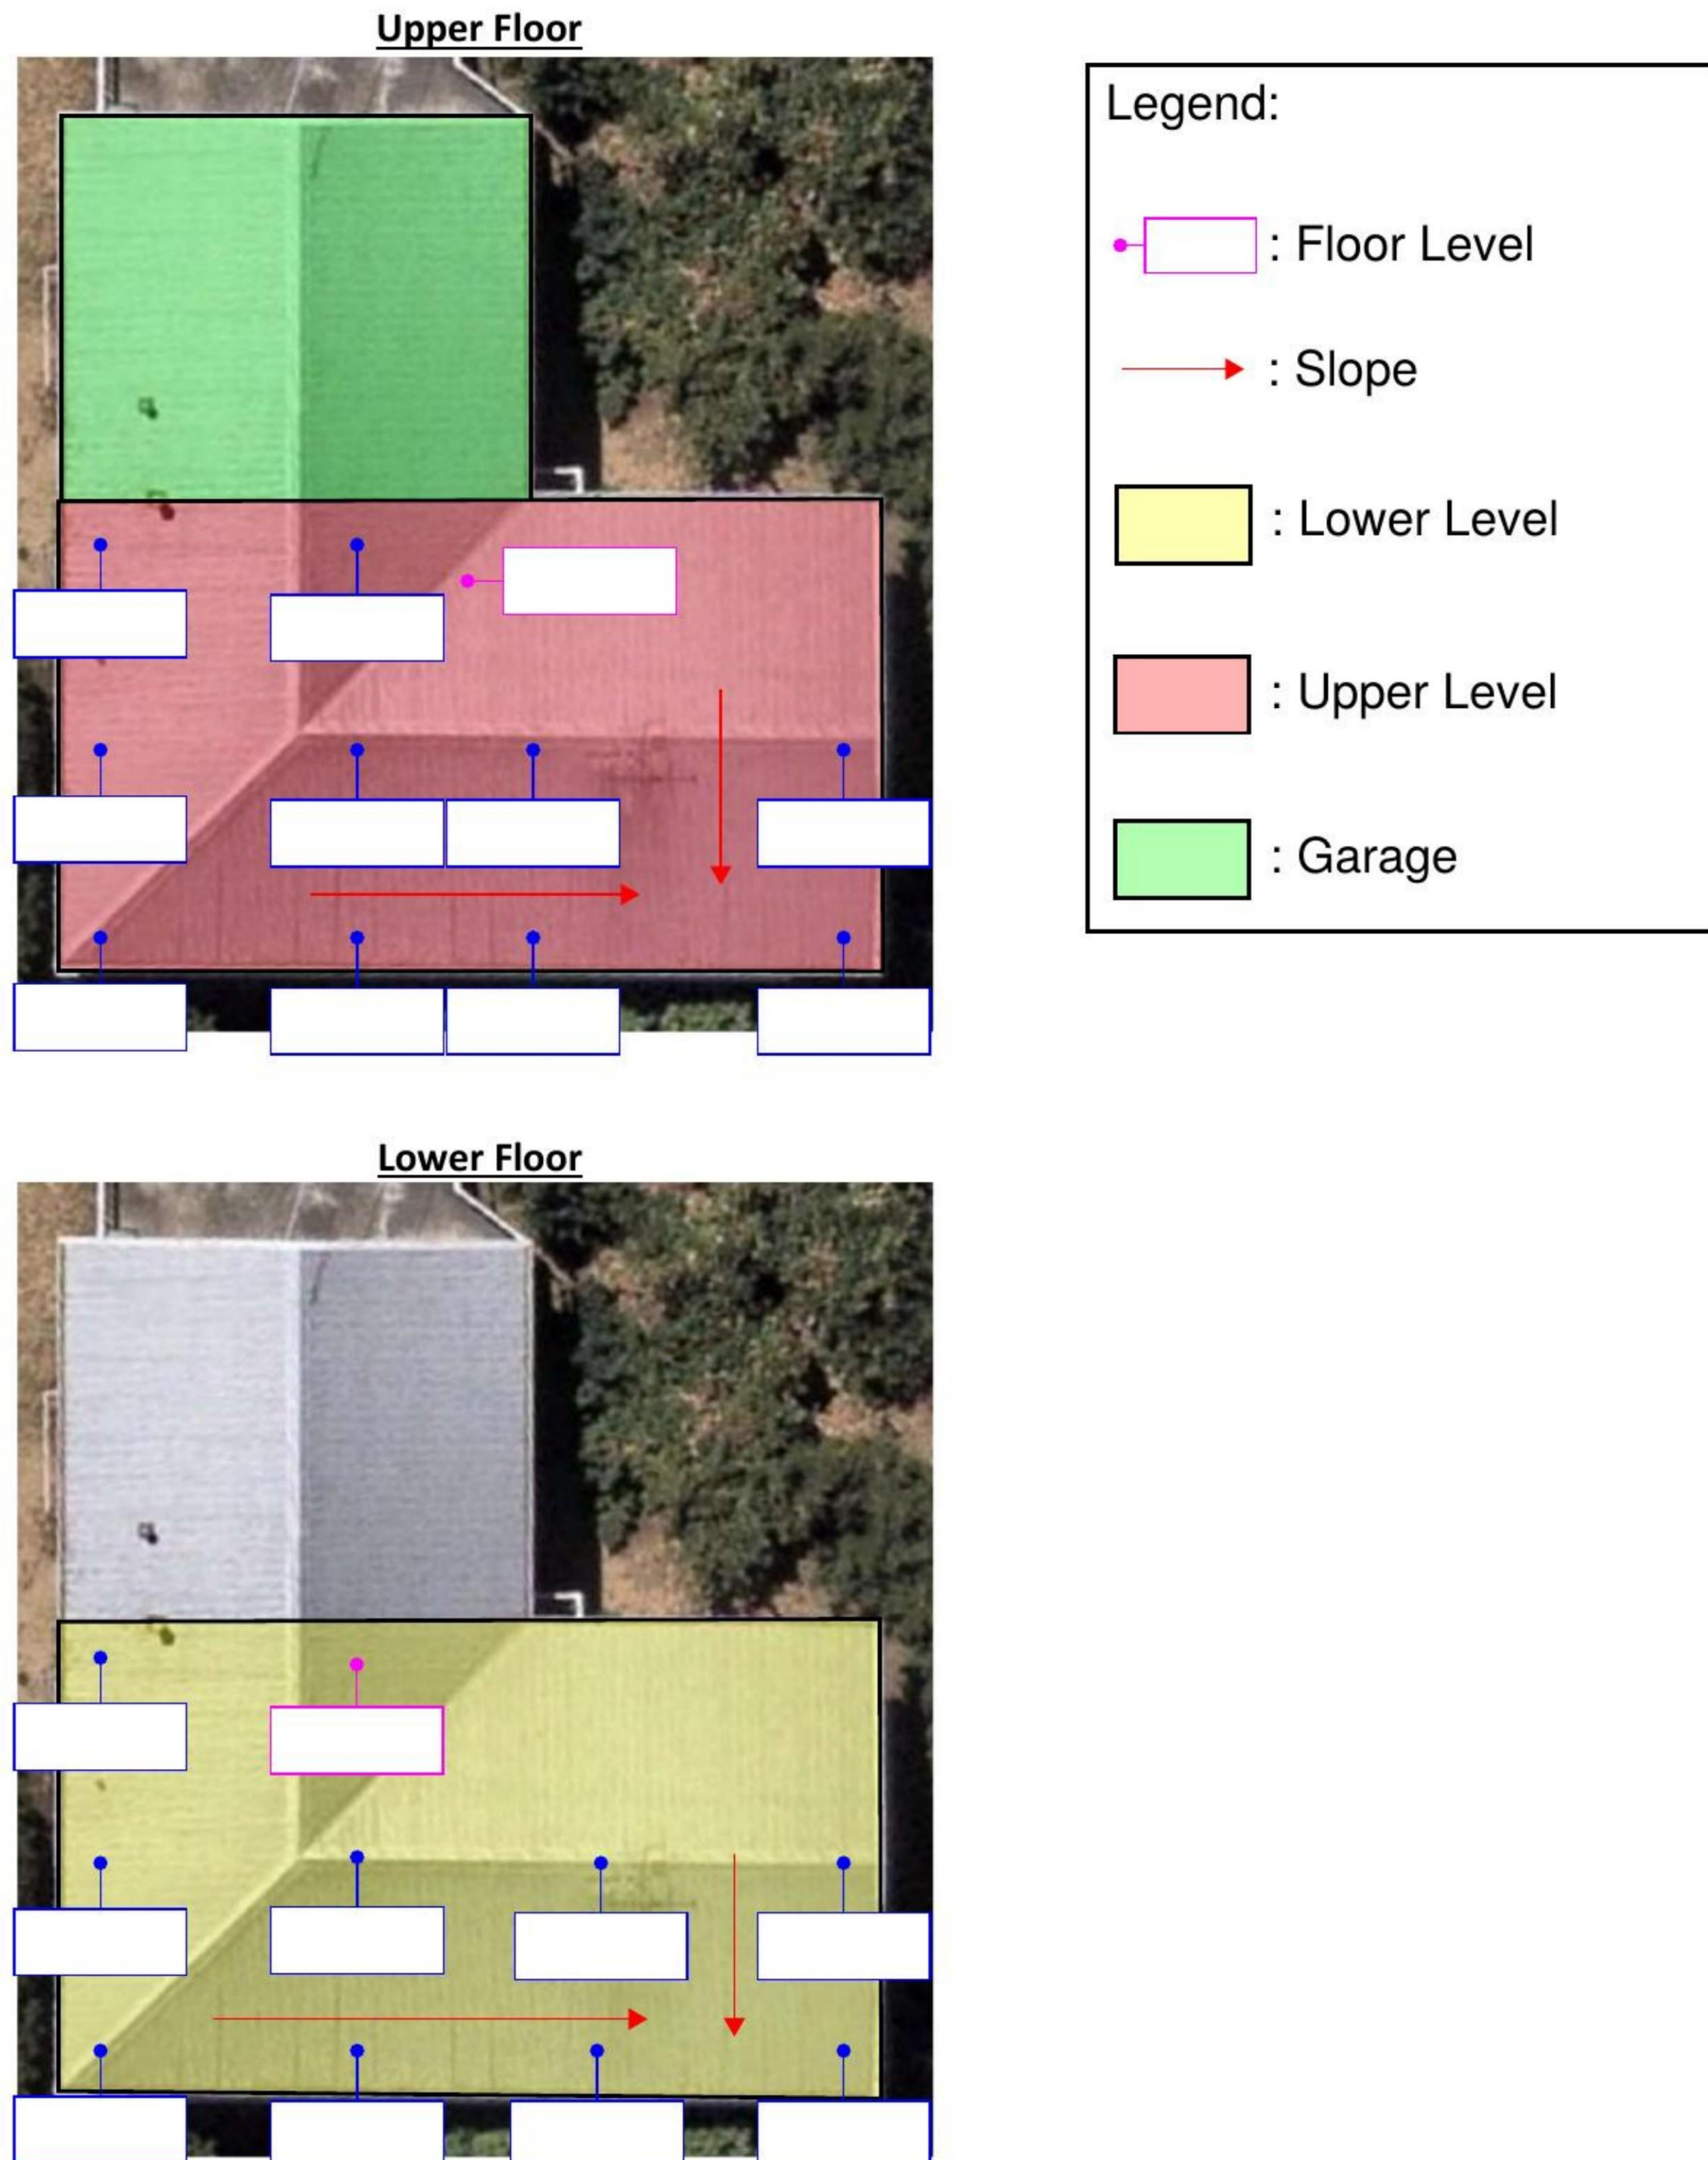
8. Appendix B: Floor Level of the Building.

Measured site data indicated deviations of **maximum 24 mm per 3 meters**, classifying the slab distortion as **Moderate Damage (Category 3)** under AS 2870 Appendix C2.

The upstairs floor level deviations of **up to 23mm per 3 metres** classify the upstairs slab distortion as **Moderate Damage (Category 3)** under AS 2870 Appendix C2.

Remedial foundation works may be considered to restore uniform support to the affected area downstairs. Depending on site conditions and the extent of movement, this may include underpinning or resin injection methods to mitigate further differential settlement.
