# Report of Property Inspection

## Engineer's Inspection Report

Prepared for [REDACTED]

[REDACTED] Rev 1.0  
25/05/2026

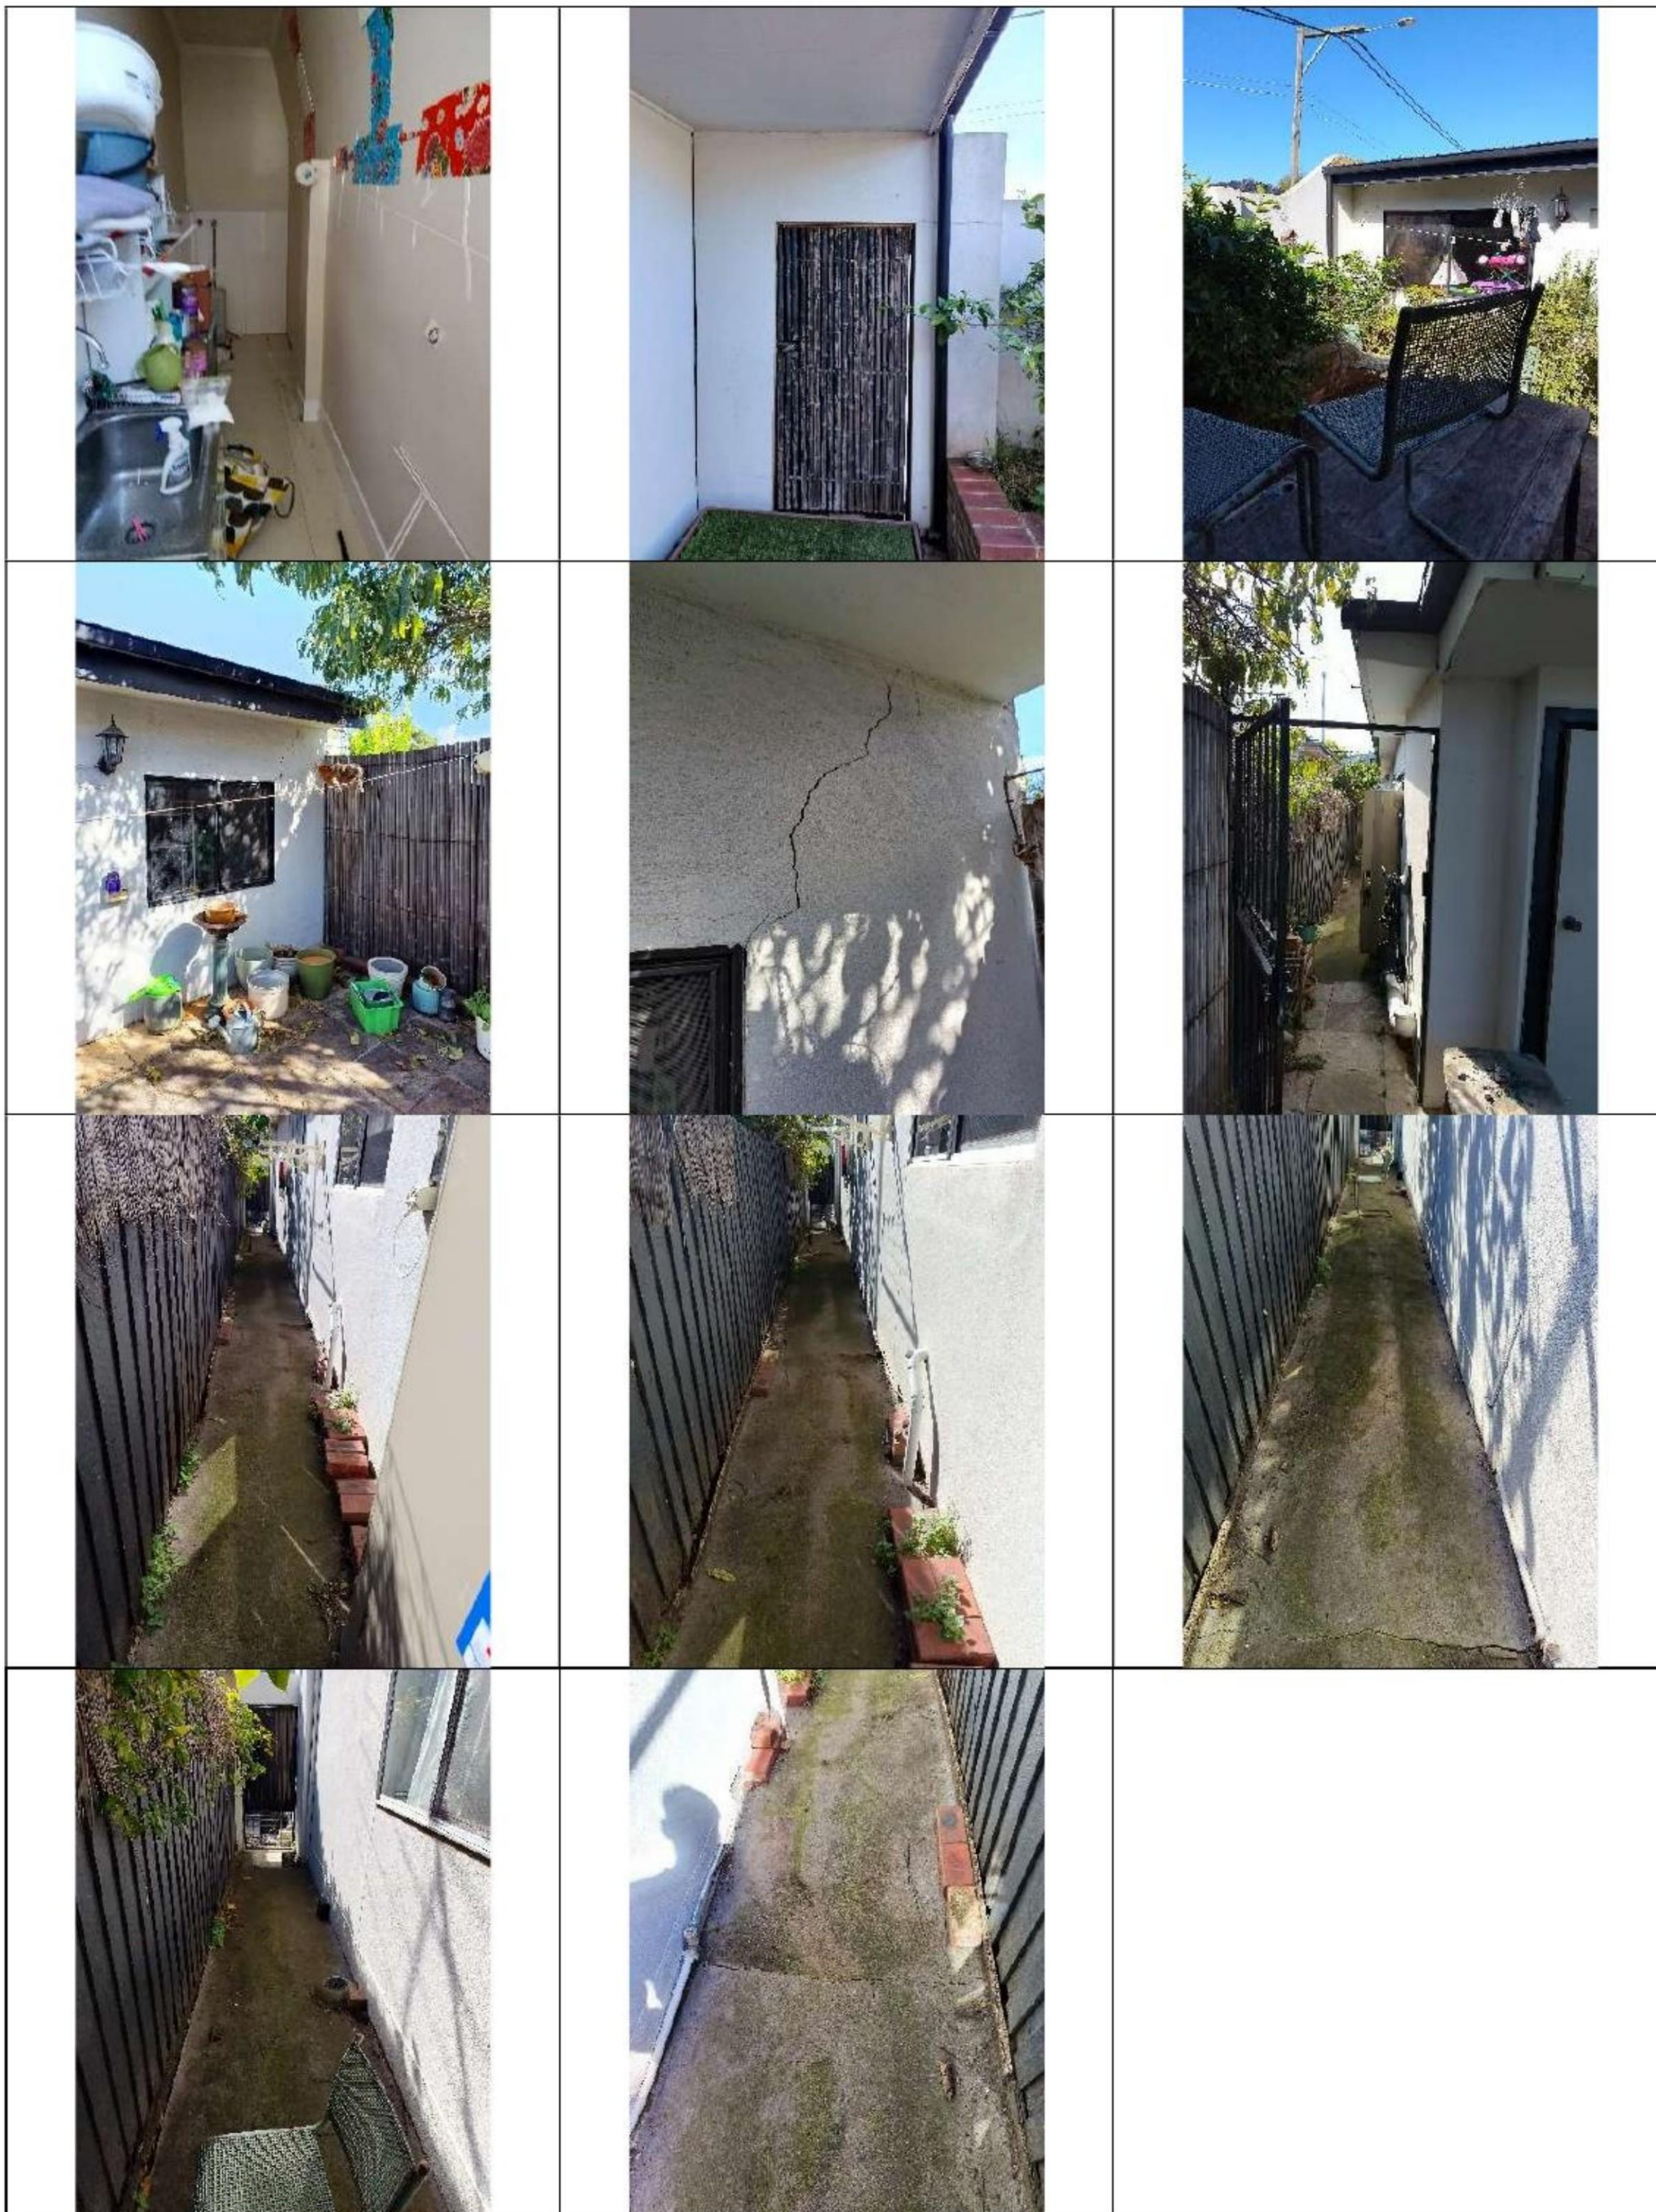
3. APPENDIX A: PHOTO LOG

Groups of cracks, ranging from approximately 2–5 mm in width, were observed on the eastern walls of the property at the time of inspection.

Cracks ranging from 2-4mm were also observed on the northern and southern walls of the property.

In accordance with AS 2870:2011, the observed wall damage is classified as **Moderate (Category 3)** for the external elements.

Hairline cracks (<0.1 mm) were observed in multiple rooms of the property, including the entranceway, hallway, and family room. A singular, larger crack of approximately 1mm was observed in the kitchen. These are consistent with footing movement, as indicated by the recorded floor level deviations. (Refer to Appendix A)

In accordance with AS 2870:2011, the observed wall damage is classified as Very Slight (**Category 1**) for internal elements.

- It is recommended that a suitably qualified builder or contractor be engaged to inspect the affected area and undertake any necessary sealing or remedial works in accordance with relevant standards.
- It is recommended that this rectification work be undertaken only after the foundation has stabilised.

Undertake crack monitoring over a 12-month period. It is recommended that the monitoring period commence after external factors (e.g. drainage or nearby vegetation) have been addressed.

Cosmetic repairs may be undertaken following the monitoring period, provided no progression in cracking is observed.
